Skylark Restoration

Purchased 12/09/2017.
Ensign 23 built by Stourport Boats
Year Late 1970's early 1980's
Length 23 feet
Beam 6 feet 10 inches
Draft 1 feet 6 inches
Hull Fibre Glass.
Power Honda BF 9.9A outboard (10HP).
(1 to 1.5 litres fuel per hour approx.)
Canal & River Trust number 104032

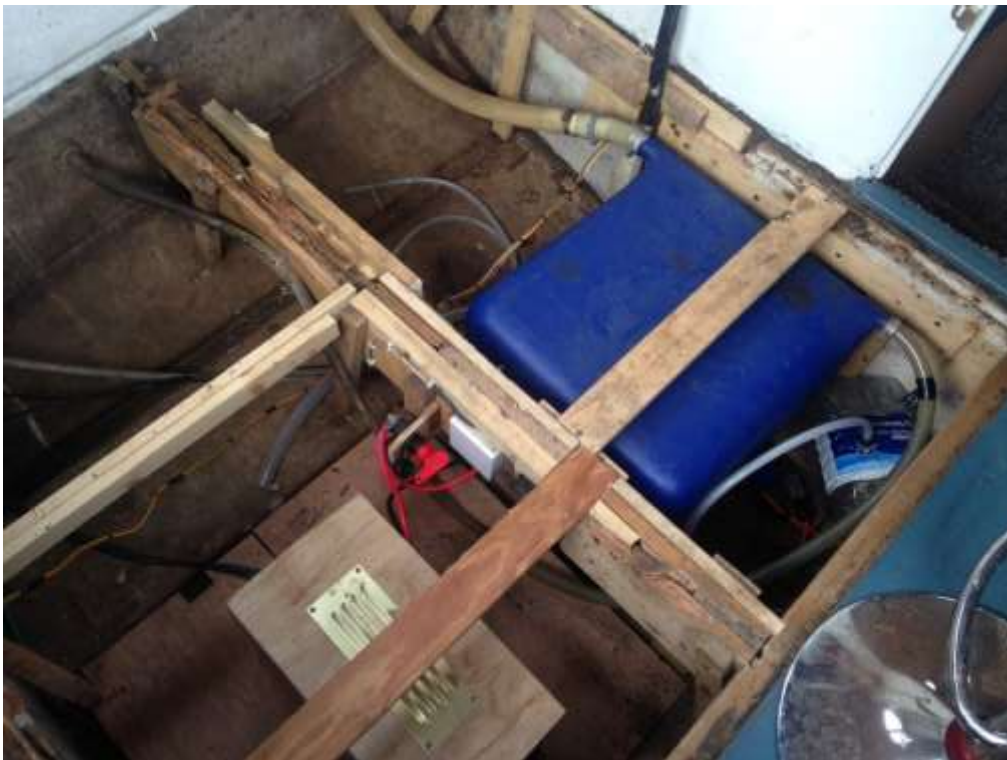
Beneath the cockpit decking mixture of rotten wood and pallet wood.

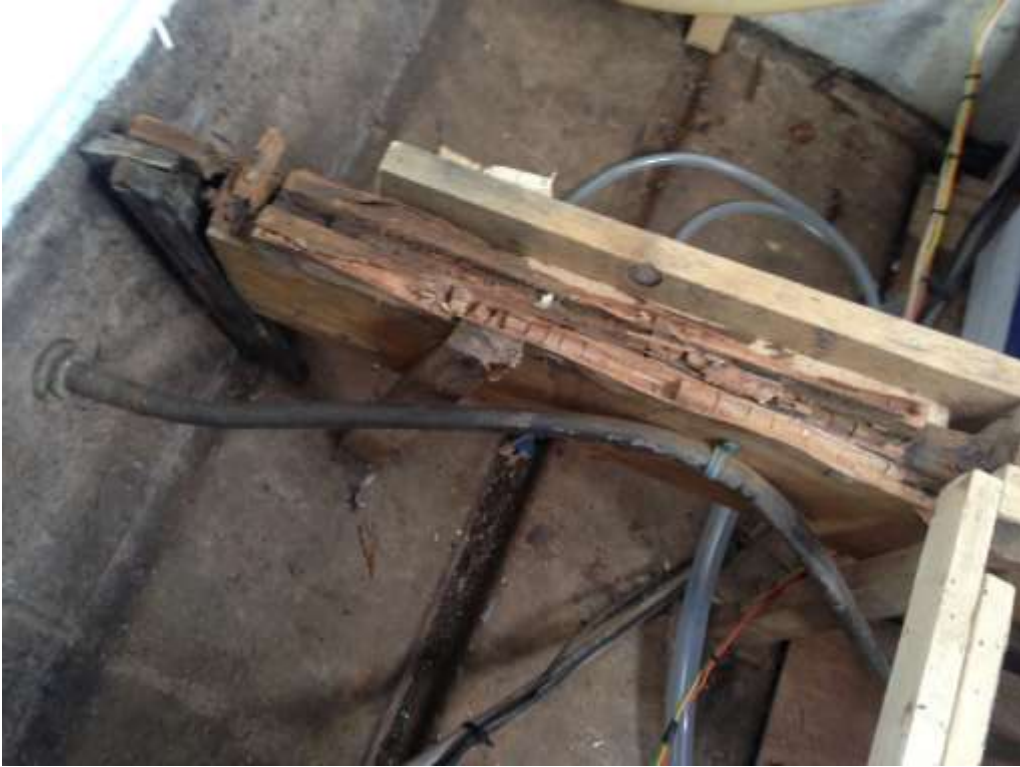
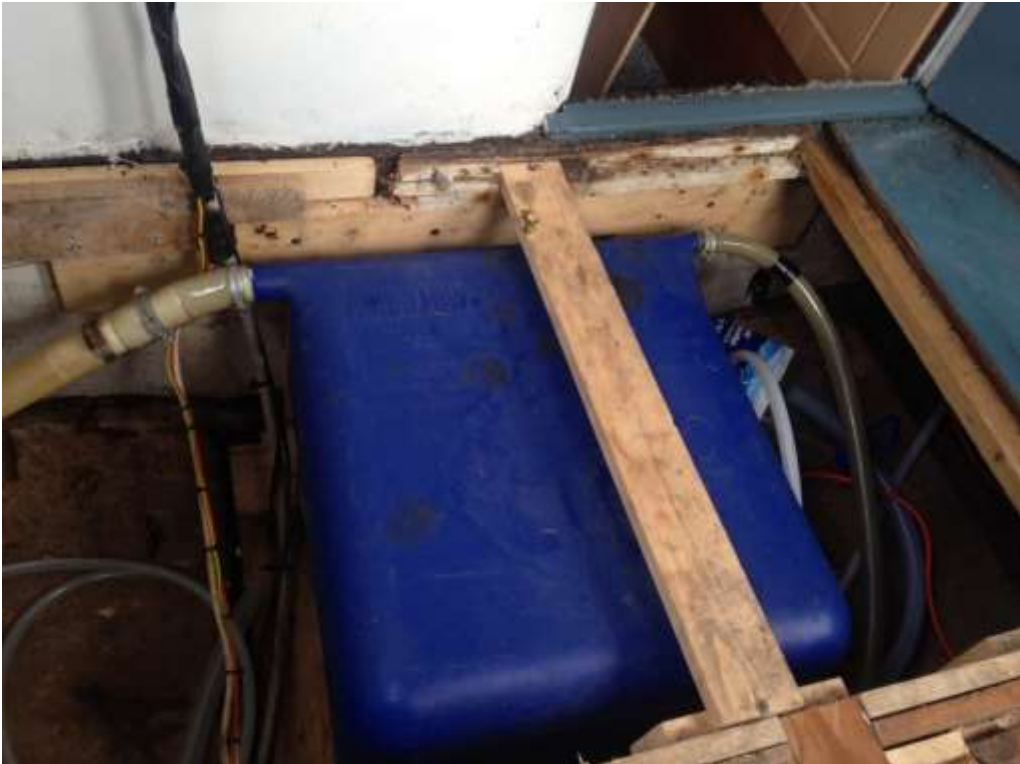
A bit more rot. All this will come out and new go in.

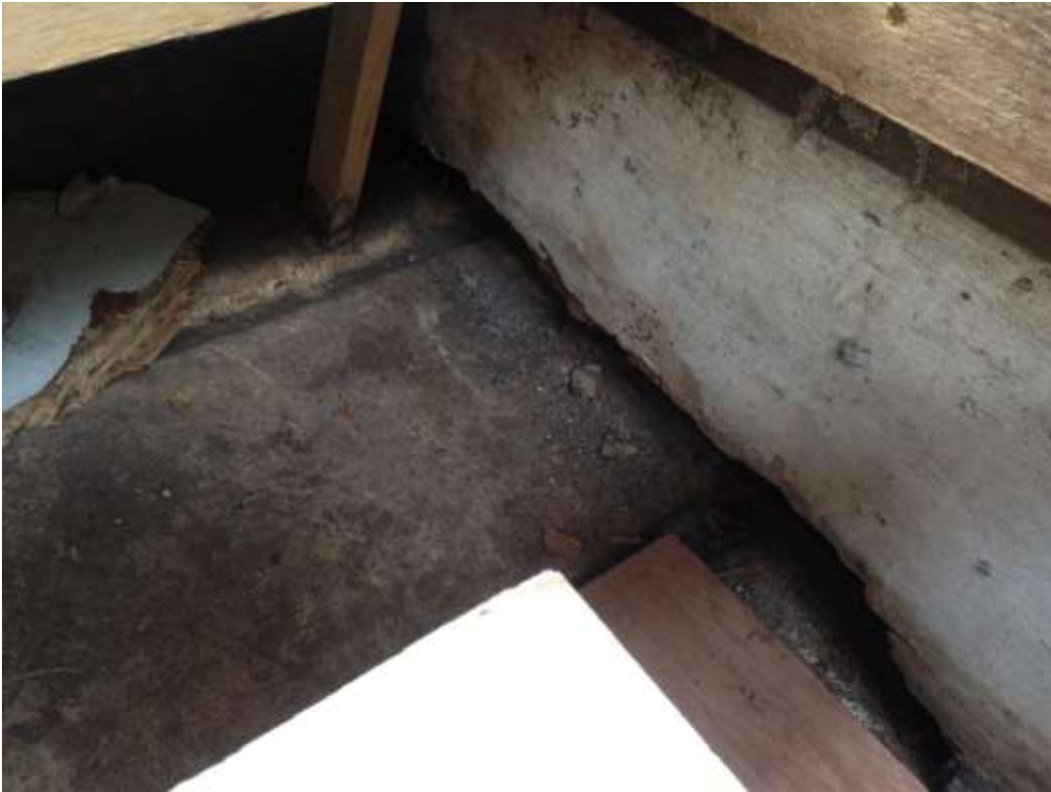
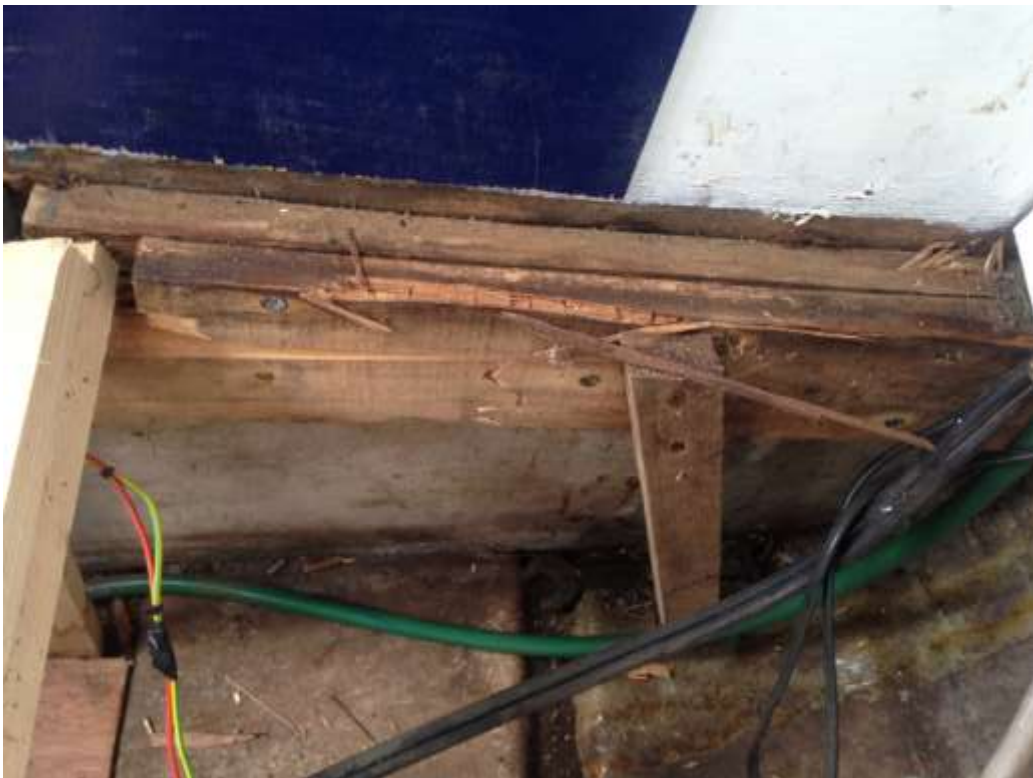
This is the bulkhead between Cockpit and rear storage area. Bottom totally rotted out.

Even the replacement wood is rotting.

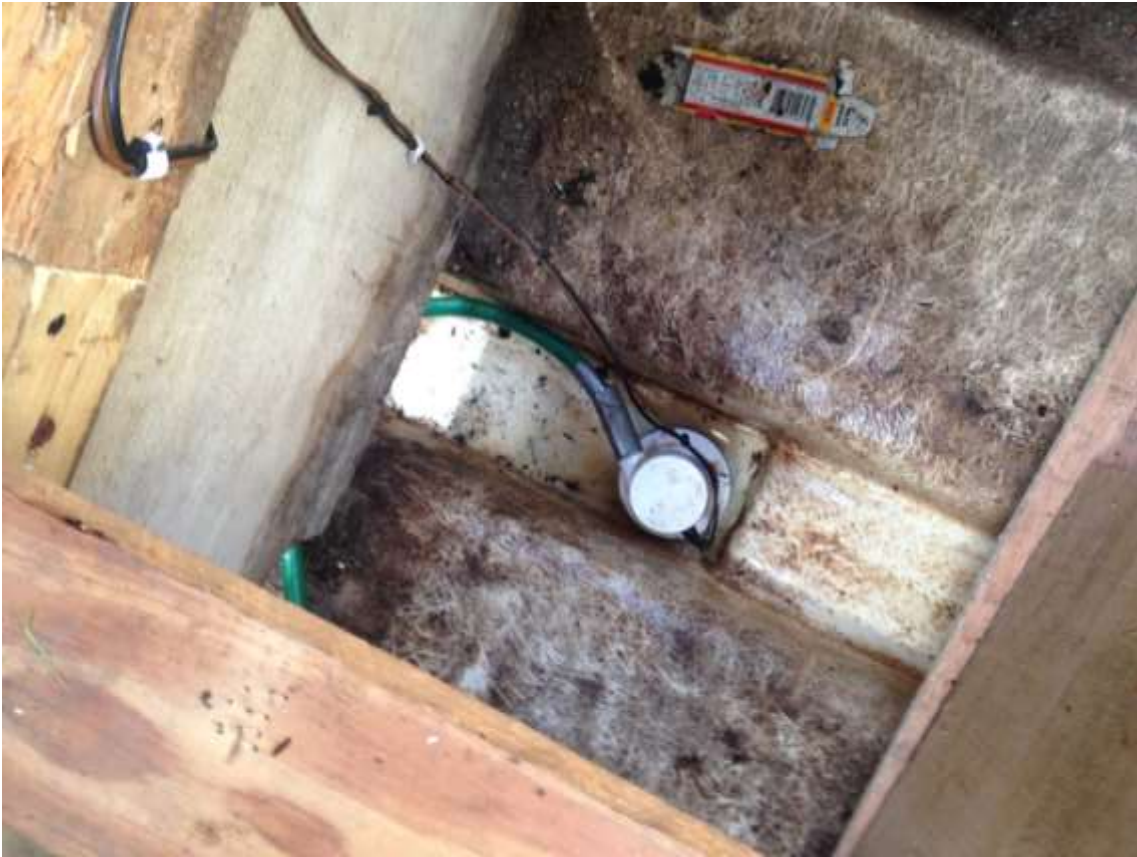
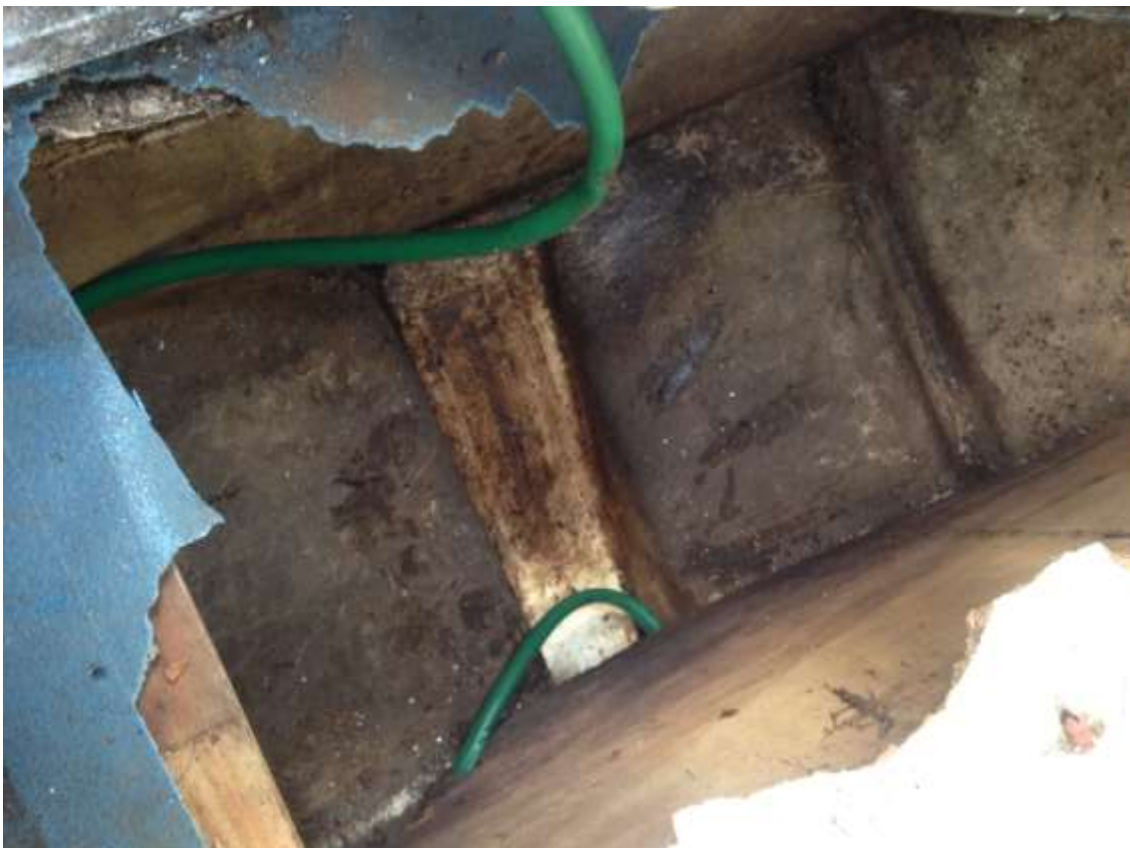
All old bilge water removed by sponging out. Bilge pipe reconnector to external fitting. All rubbish and loose material removed from below deck in cockpit and storage area. 09/10/2017

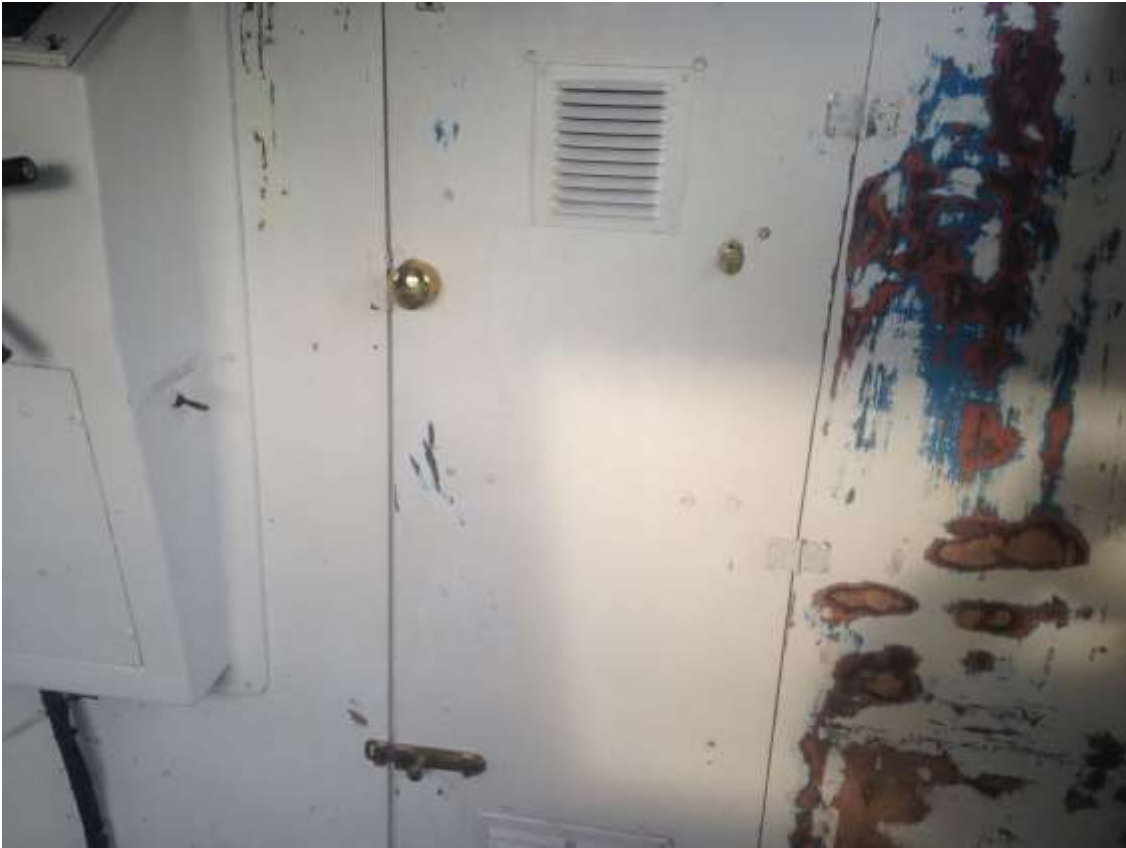
Starting to sand the cabin wall. 10/11/2017

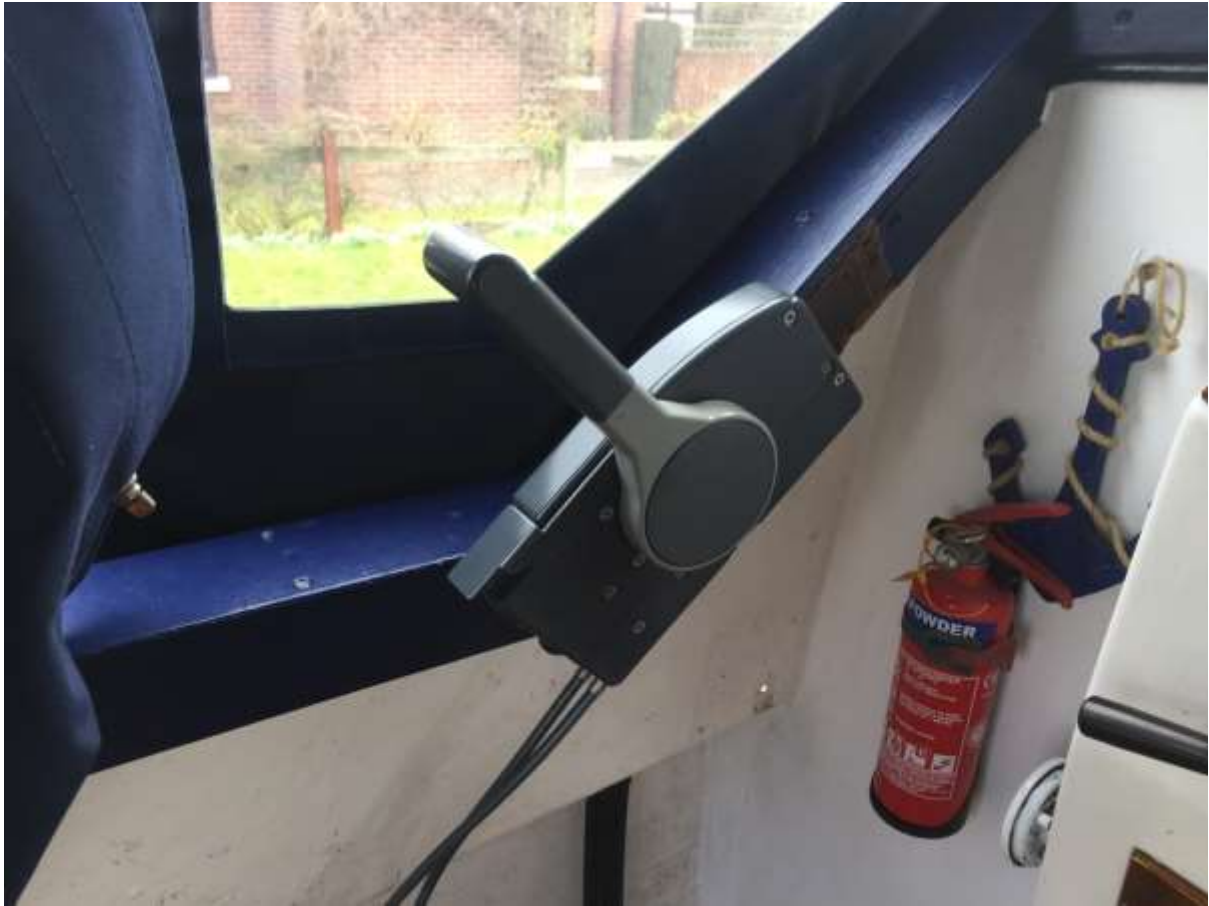
Fitted Yamaha 703 remote control.
Need to convert from push to pull 6/3/2018

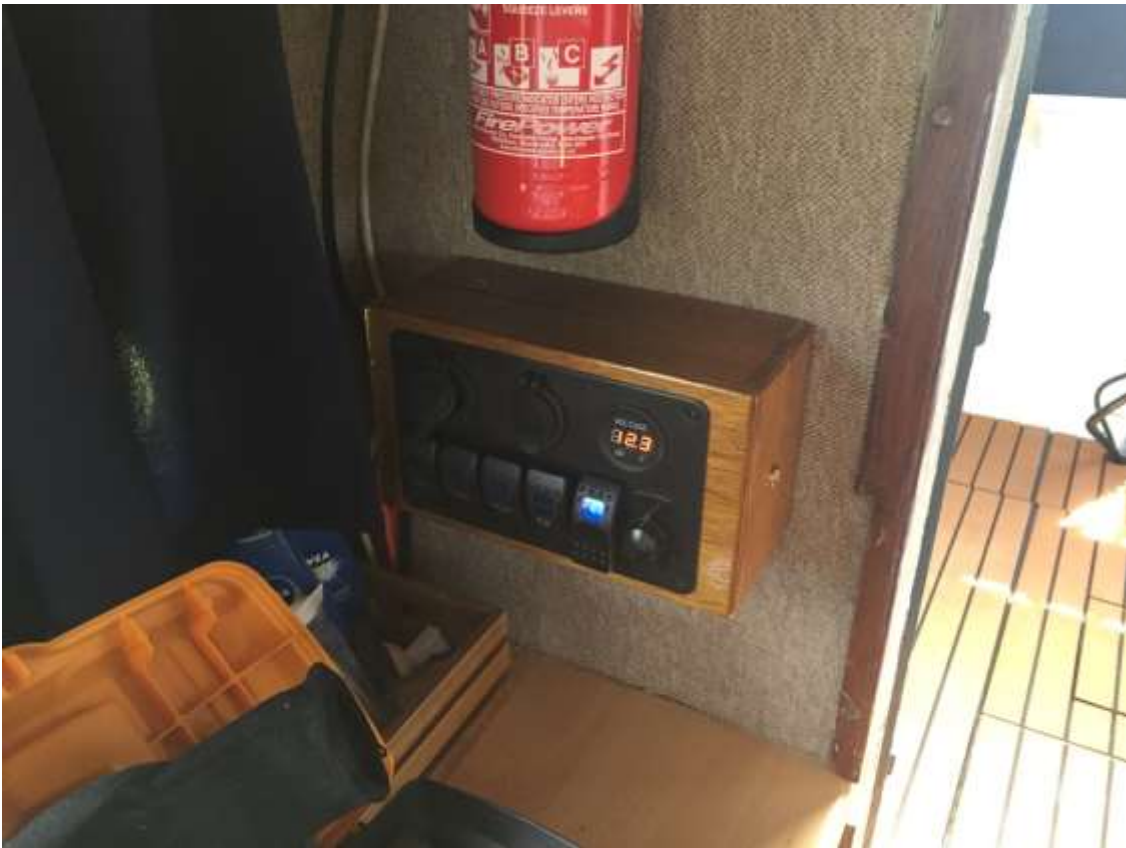
Boat re-wired except for dashboard 14/3/2018
Stripping old varnish off wheel 19/3/2018

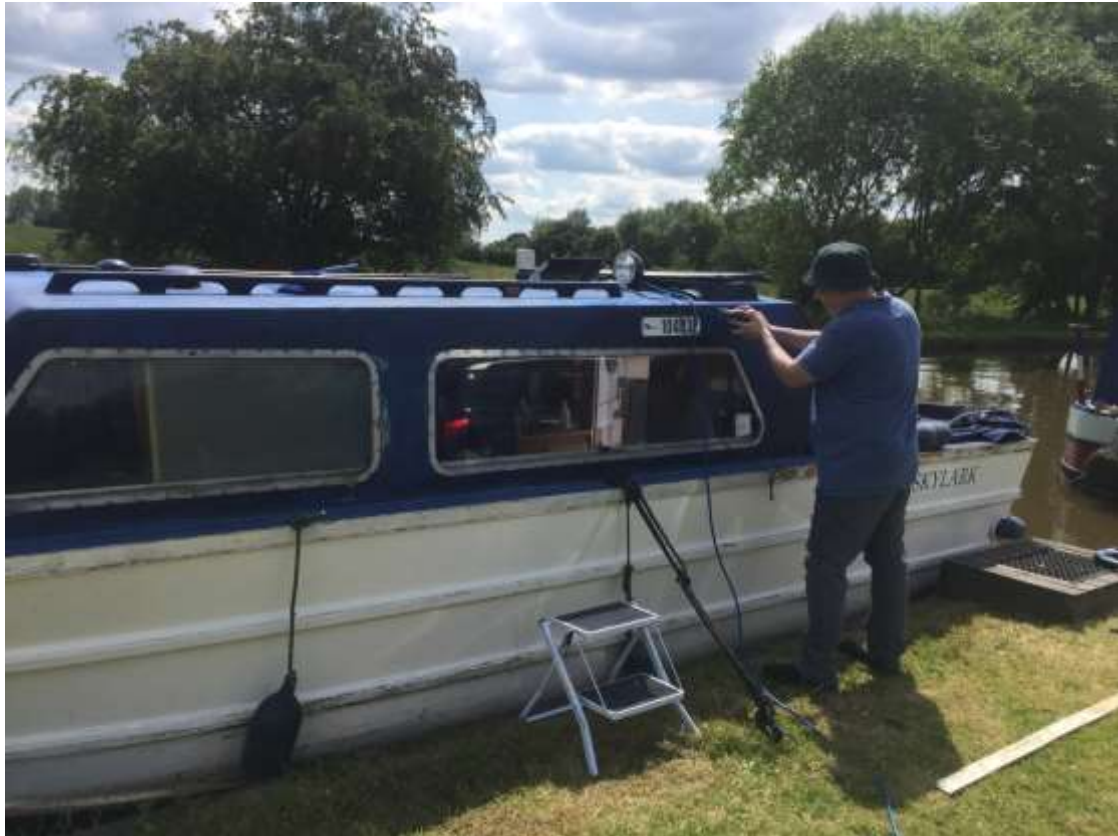
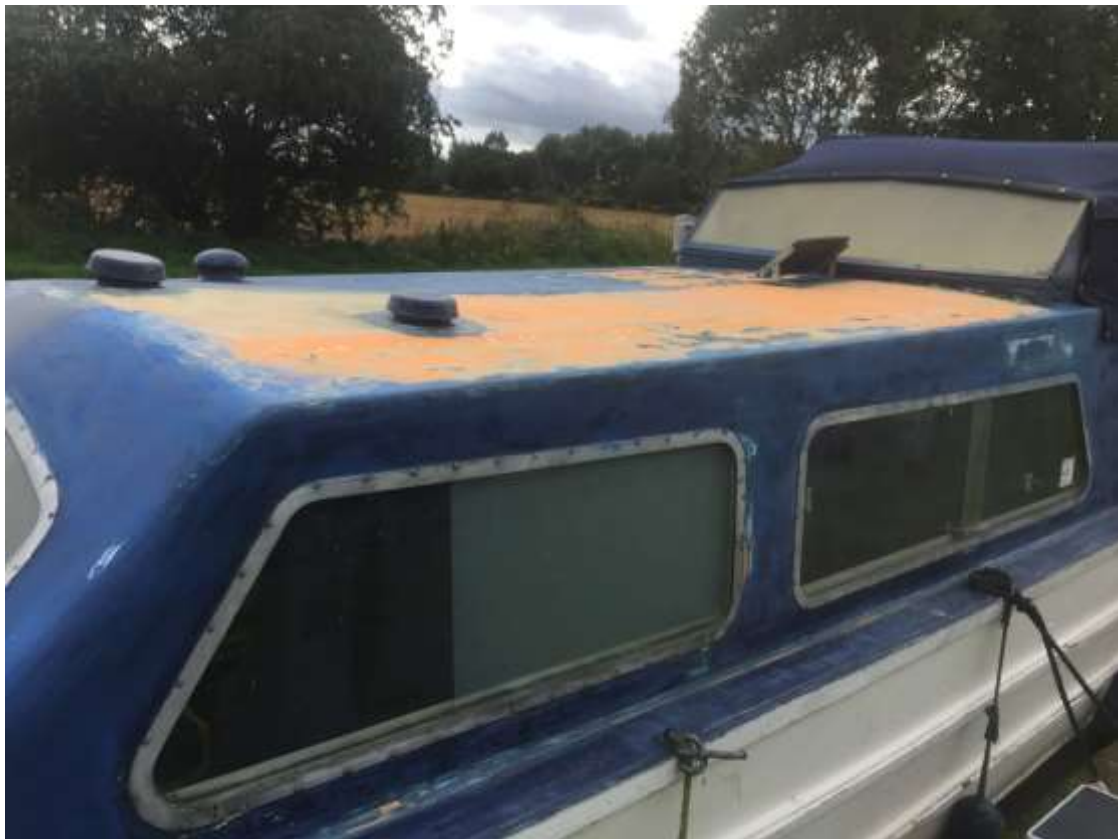
Starting the sanding down the cracked surfaces to repaint (July 2019)
Had to sand roof right back to original Orange Gelcoat.

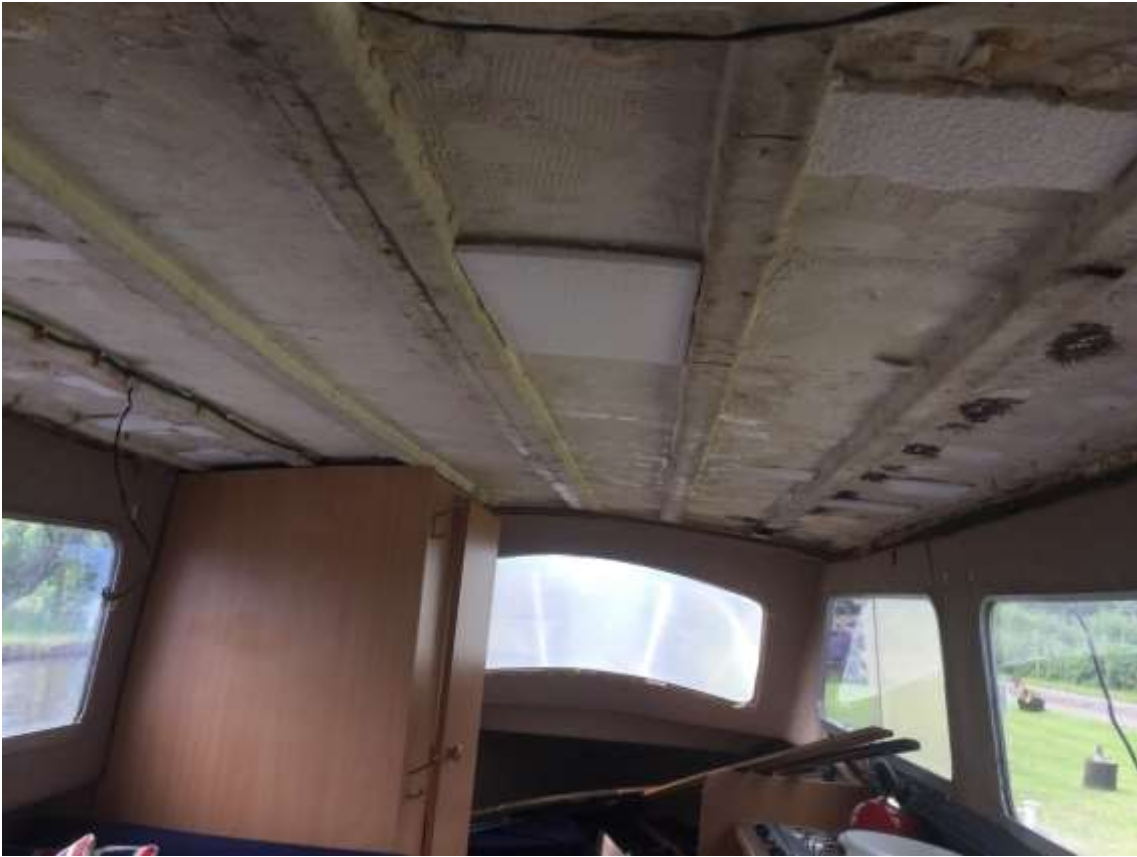
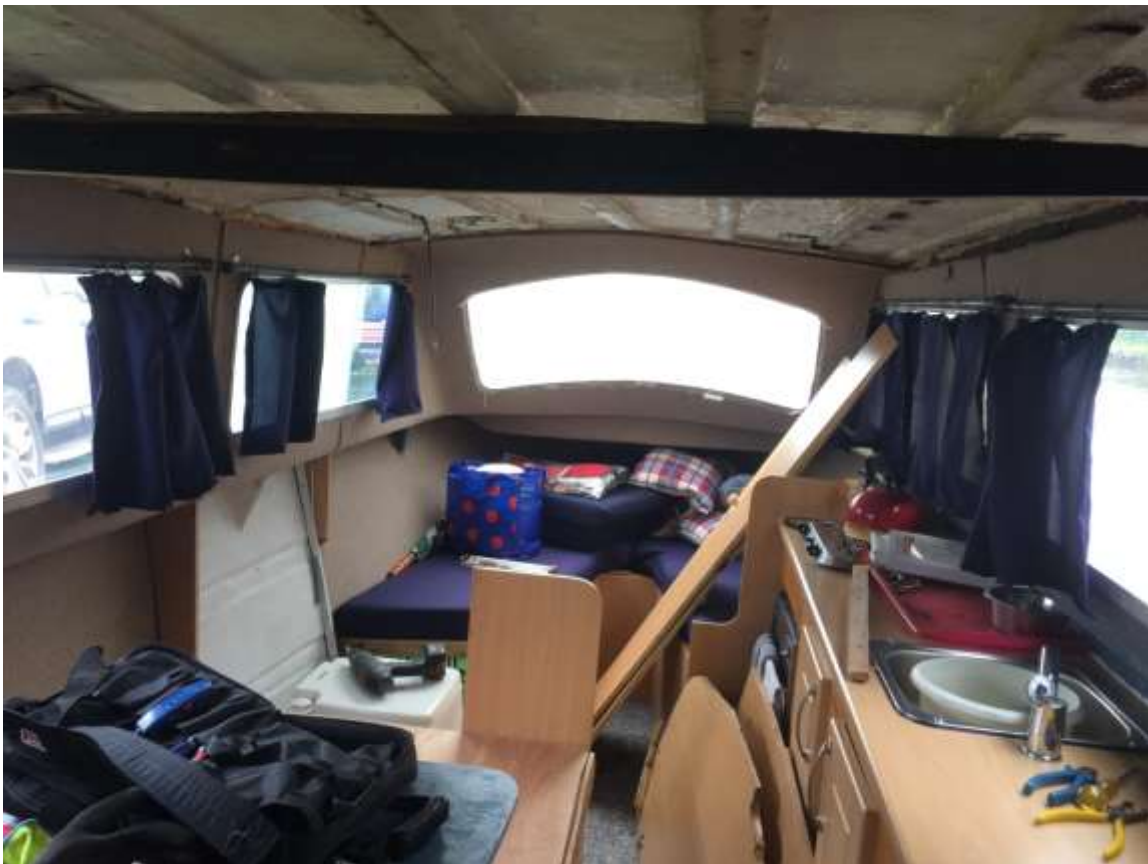
Had to strip out interior roof to gain access to Hand rail screws

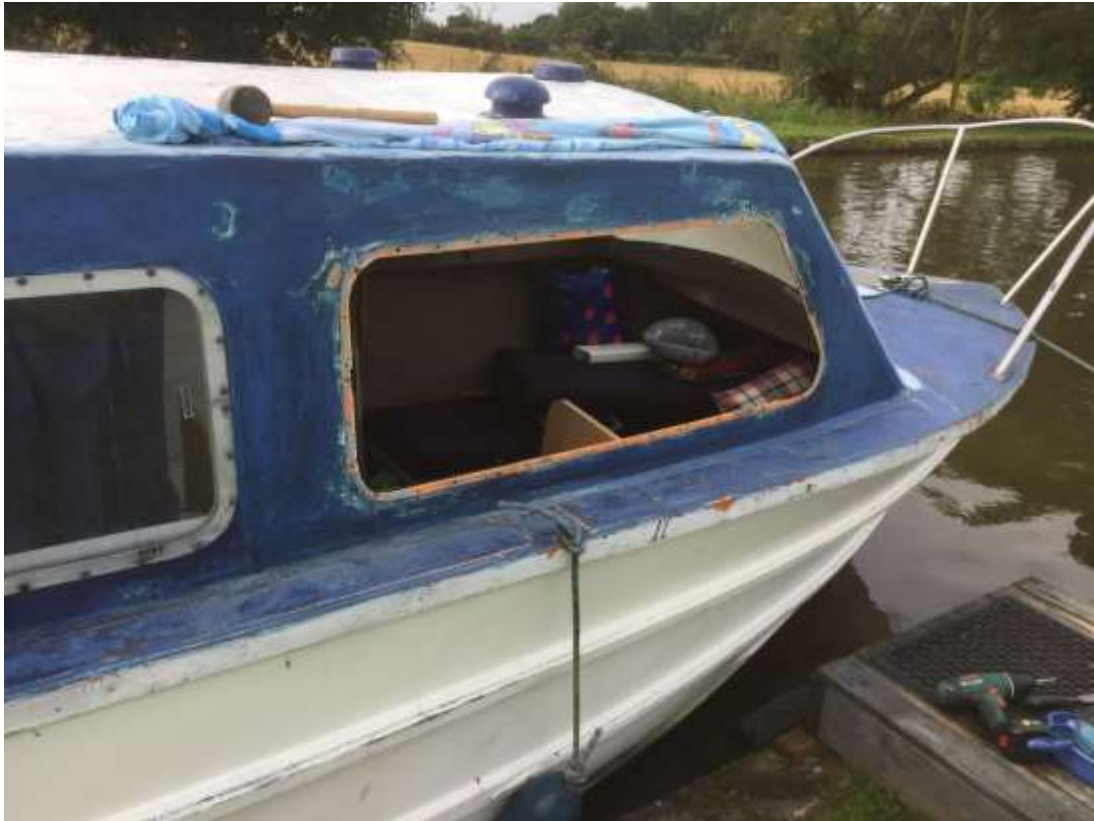
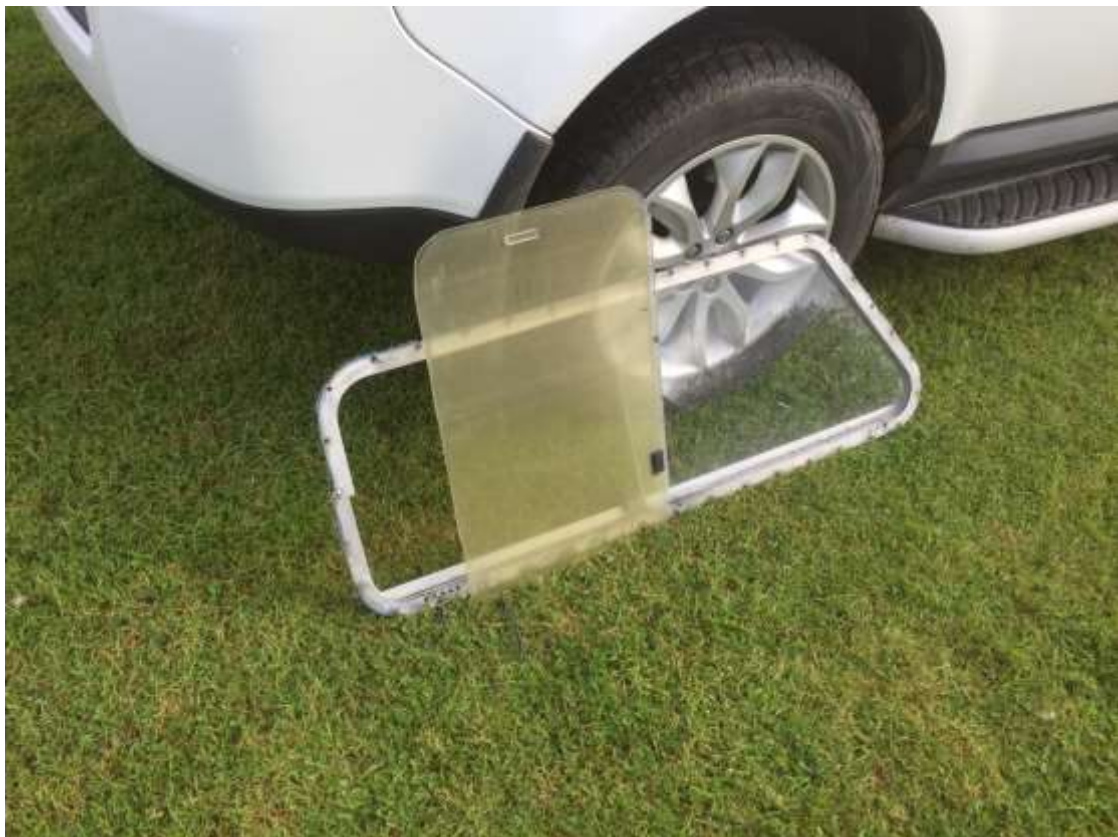
Removed all the leaking pop rivets and replaced with stainless steel nuts and bolts.
Replaced old Perspex window and polished aluminium frames. (September 2019)

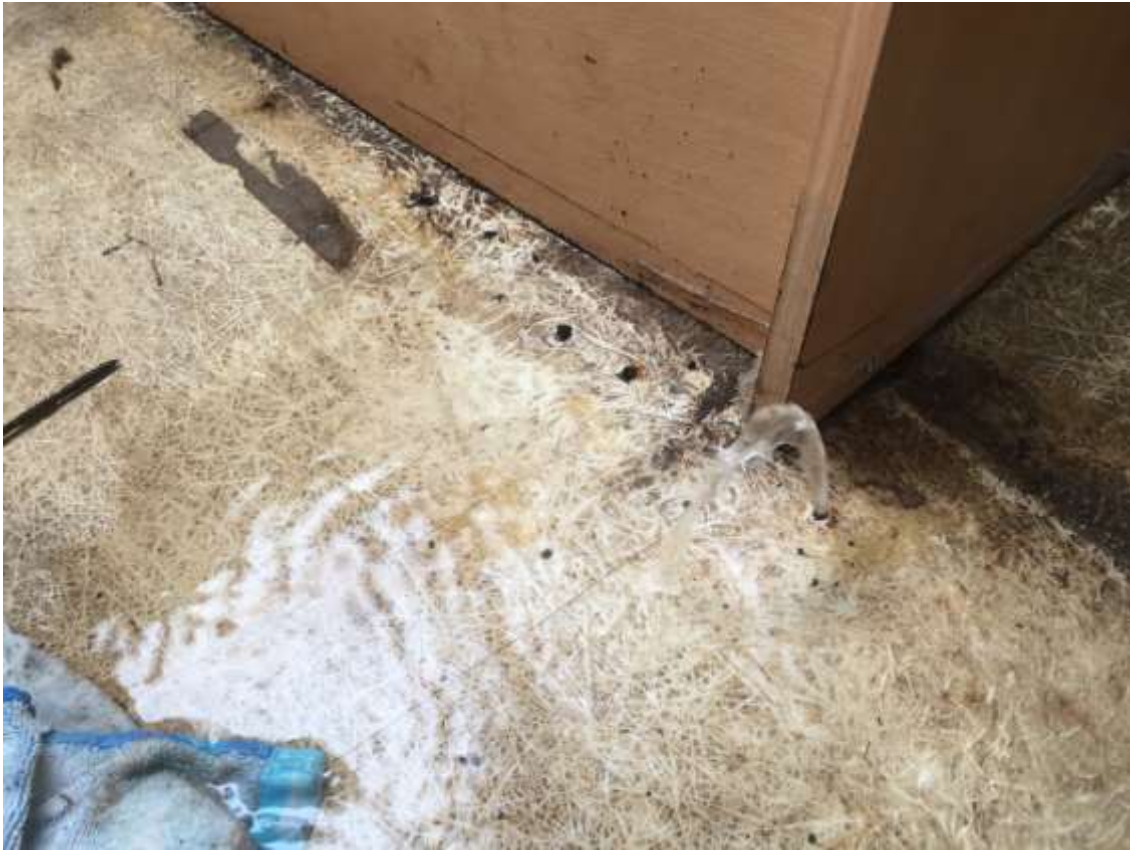
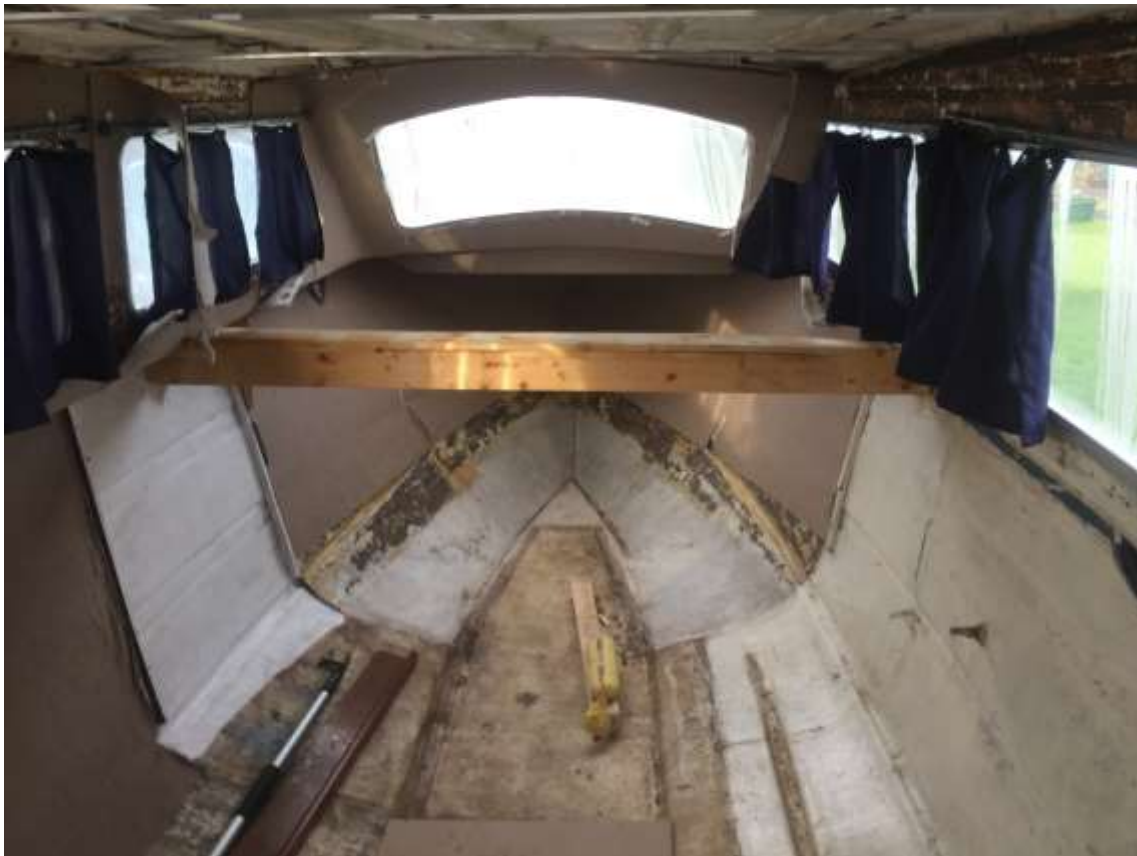
Just when we decided not to remove boat from the water. We detected a leak.
A total strip out of the inside strengthening bar fitted ready for lifting out.

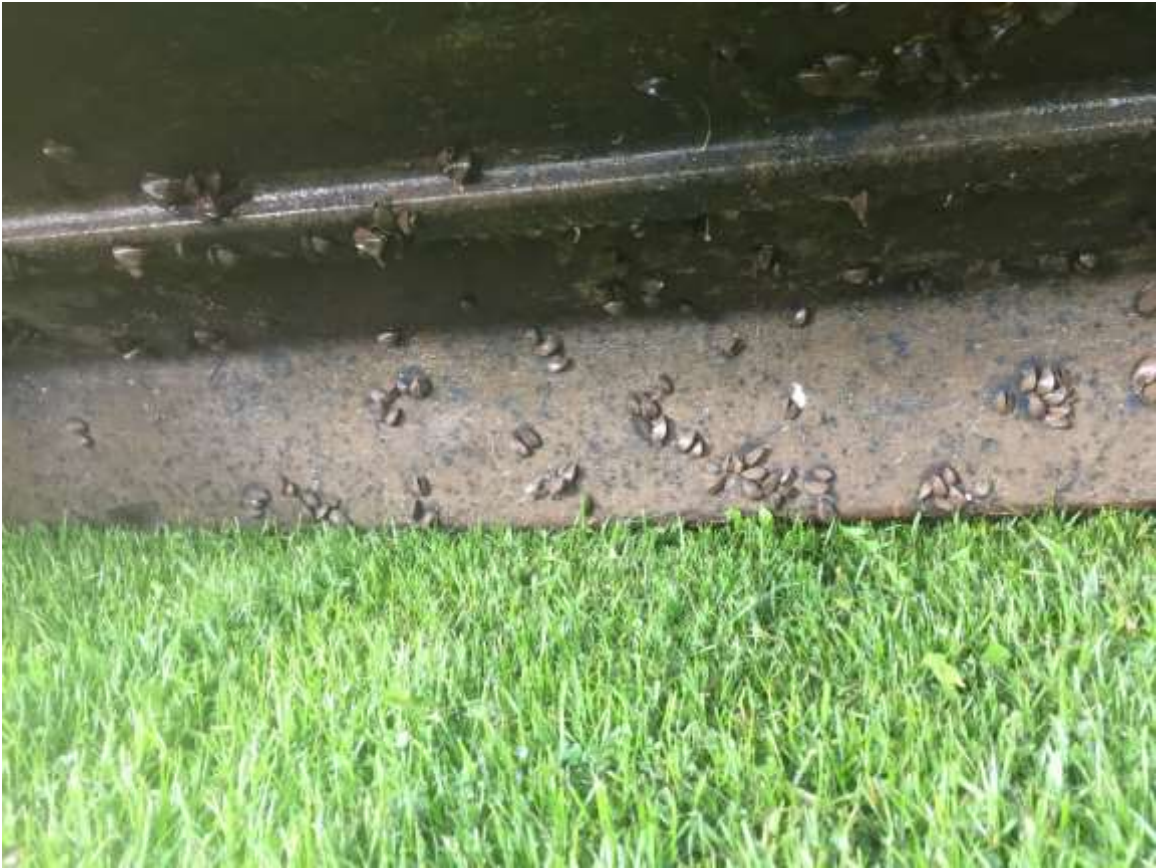
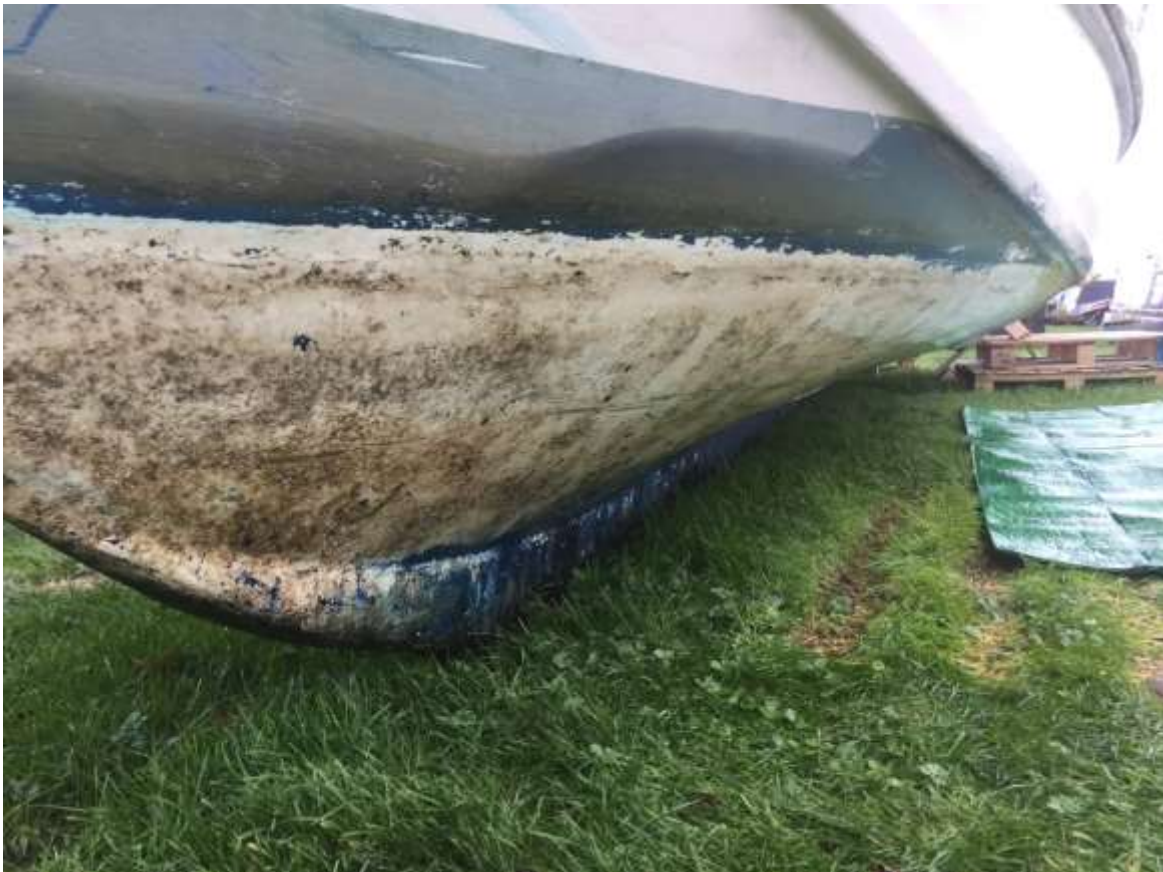
Had to scrape off all the shell fish (November 2019)
Jet washed the hull prior to sanding

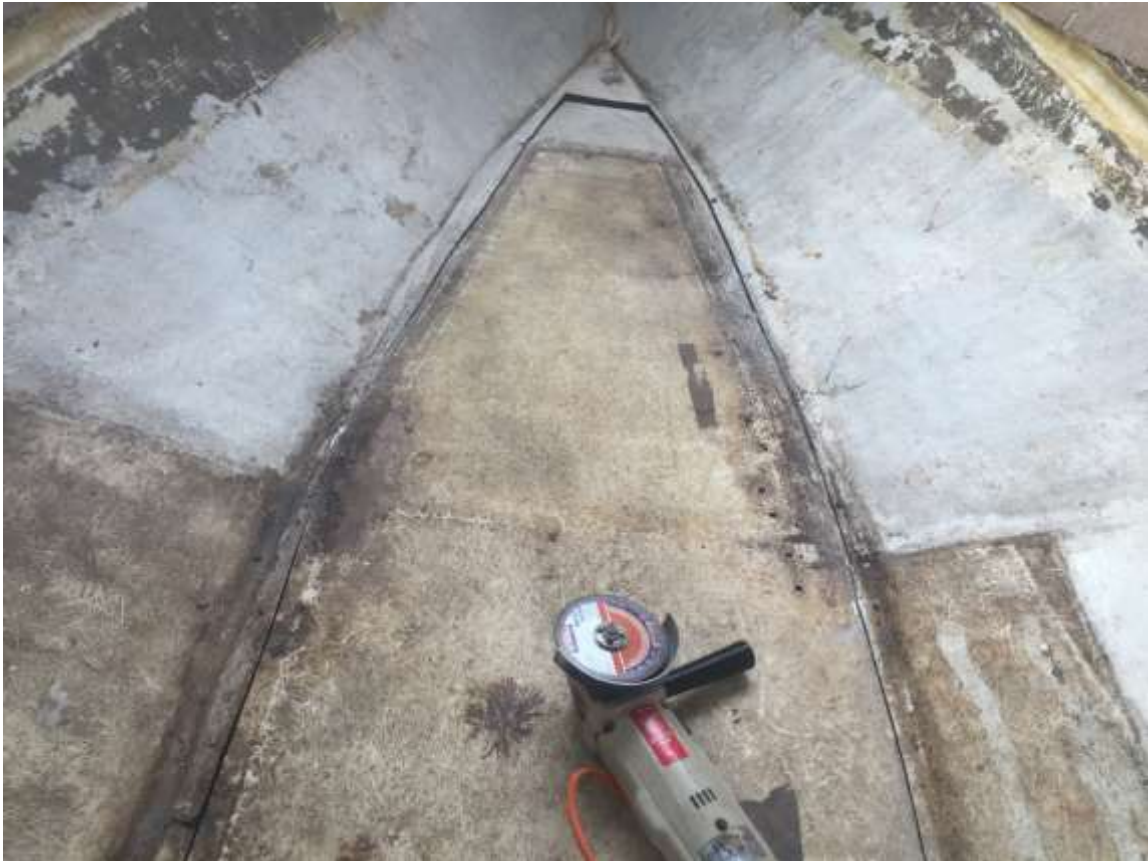
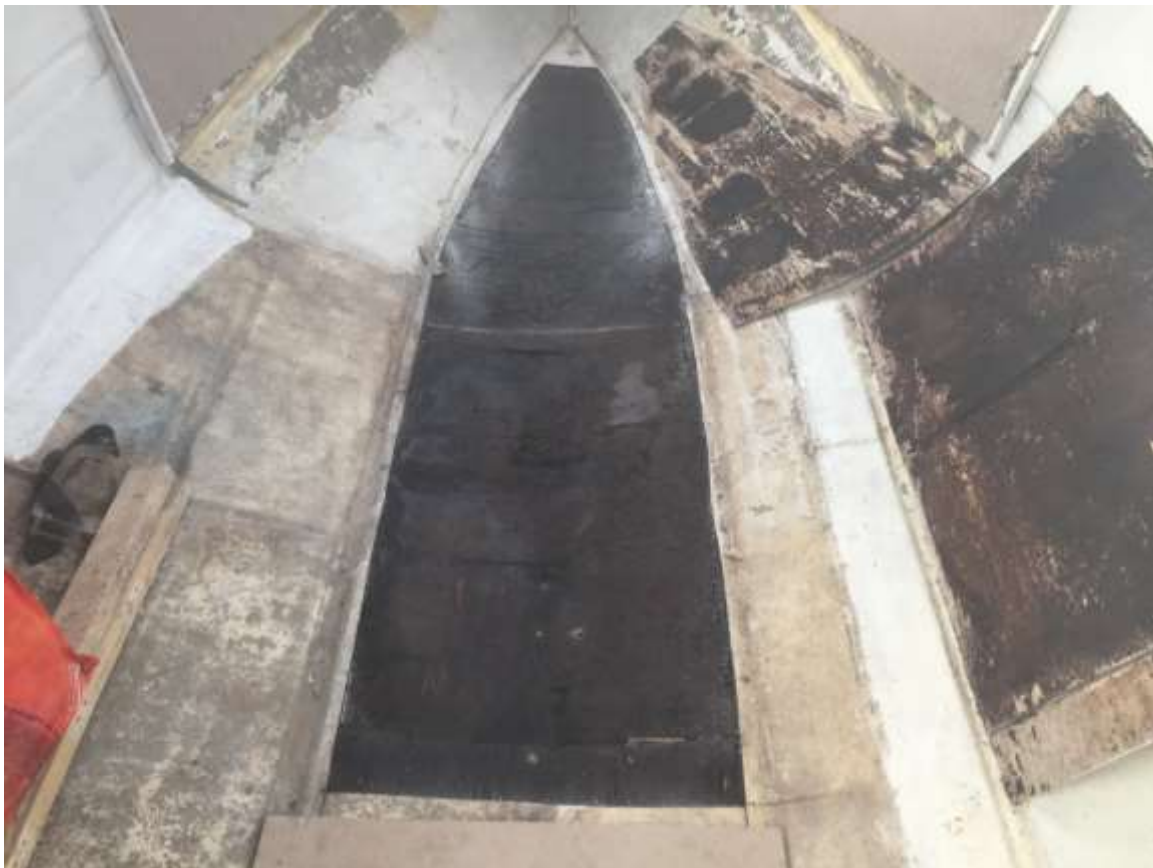
Had to cut through false floor and remove the ballast. Loose sand. (November 2019)
14 bags!

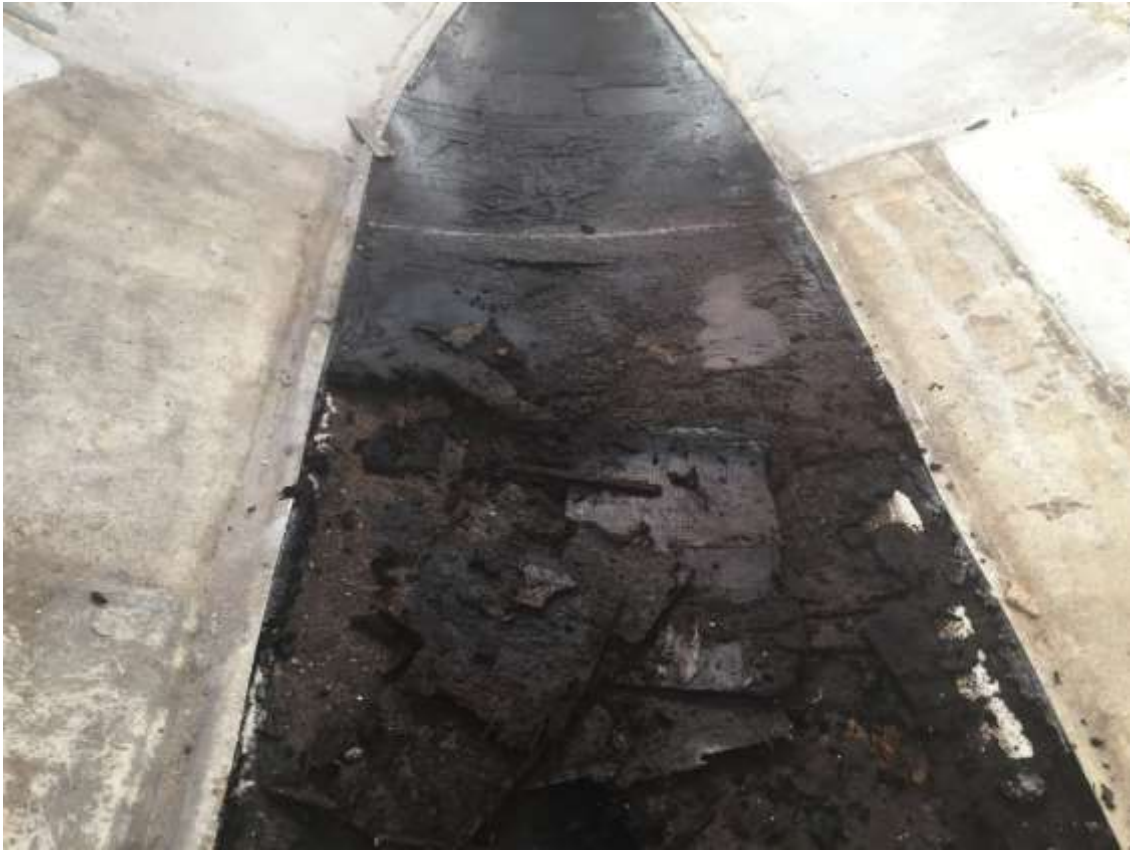
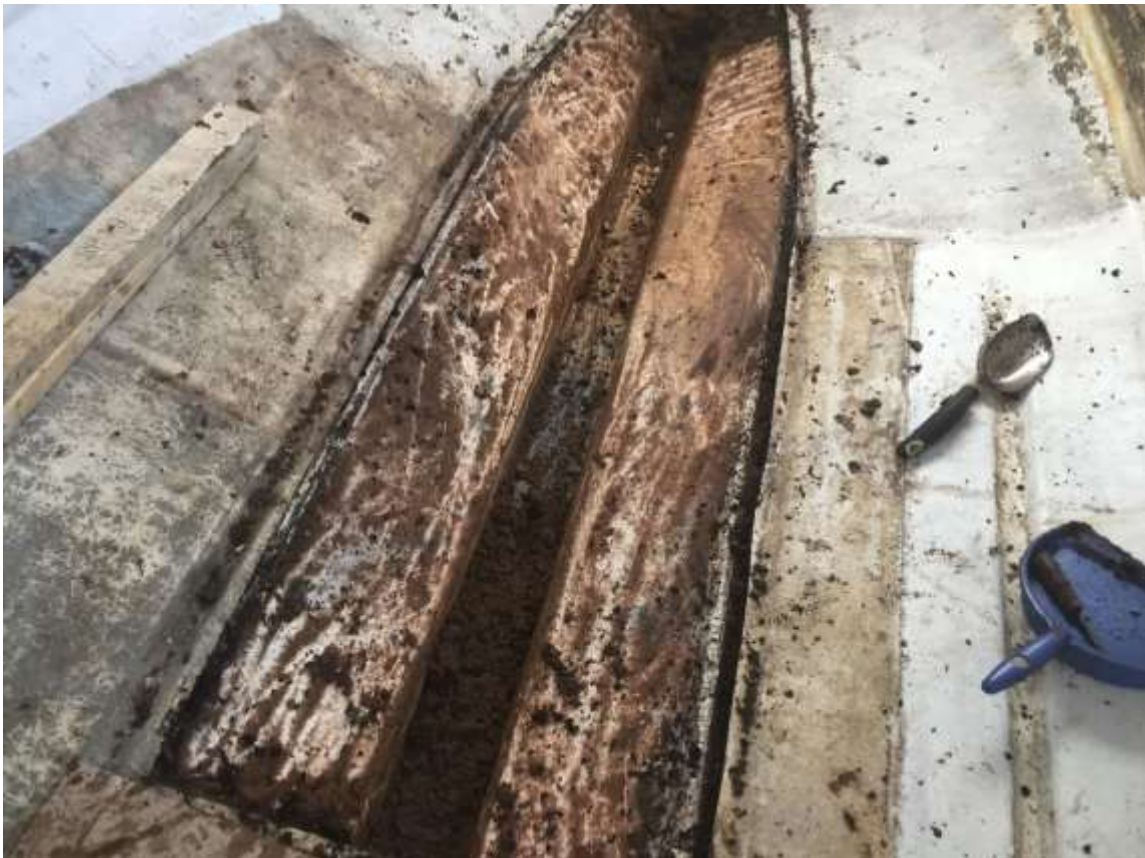
Originally there had been plywood between fibreglass and sand but this had rotted completely.

Four holes patched with fibreglass resin and matting (8th November 2019)
Two handrails completely stripped and re varnished (July 2019)
