Skylark Restoration

Purchased 12/09/2017.
Ensign 23 built by Stourport Boats
Year Late 1970's early 1980's
Length 23 feet
Beam 6 feet 10 inches
Draft 1 feet 6 inches
Hull Fibre Glass.
Power Honda BF 9.9A outboard (10HP).
(1 to 1.5 litres fuel per hour approx.)
Canal & River Trust number 104032

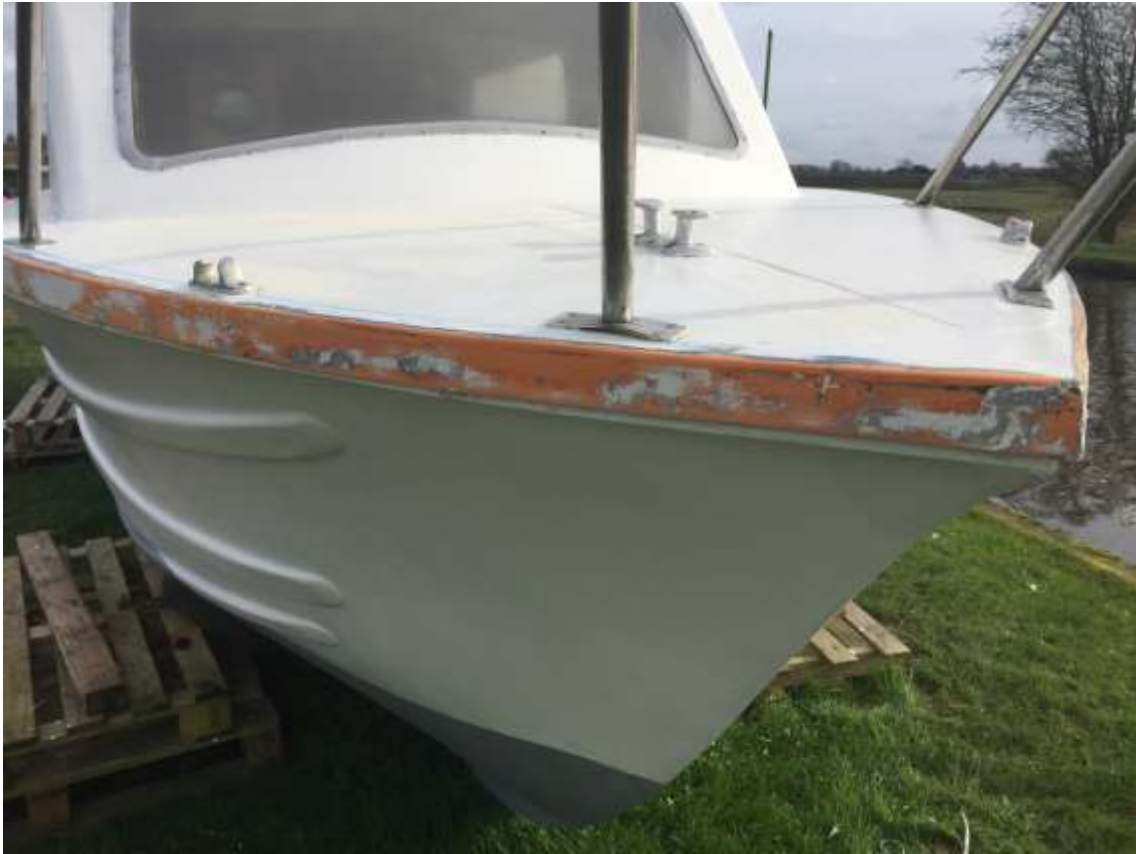
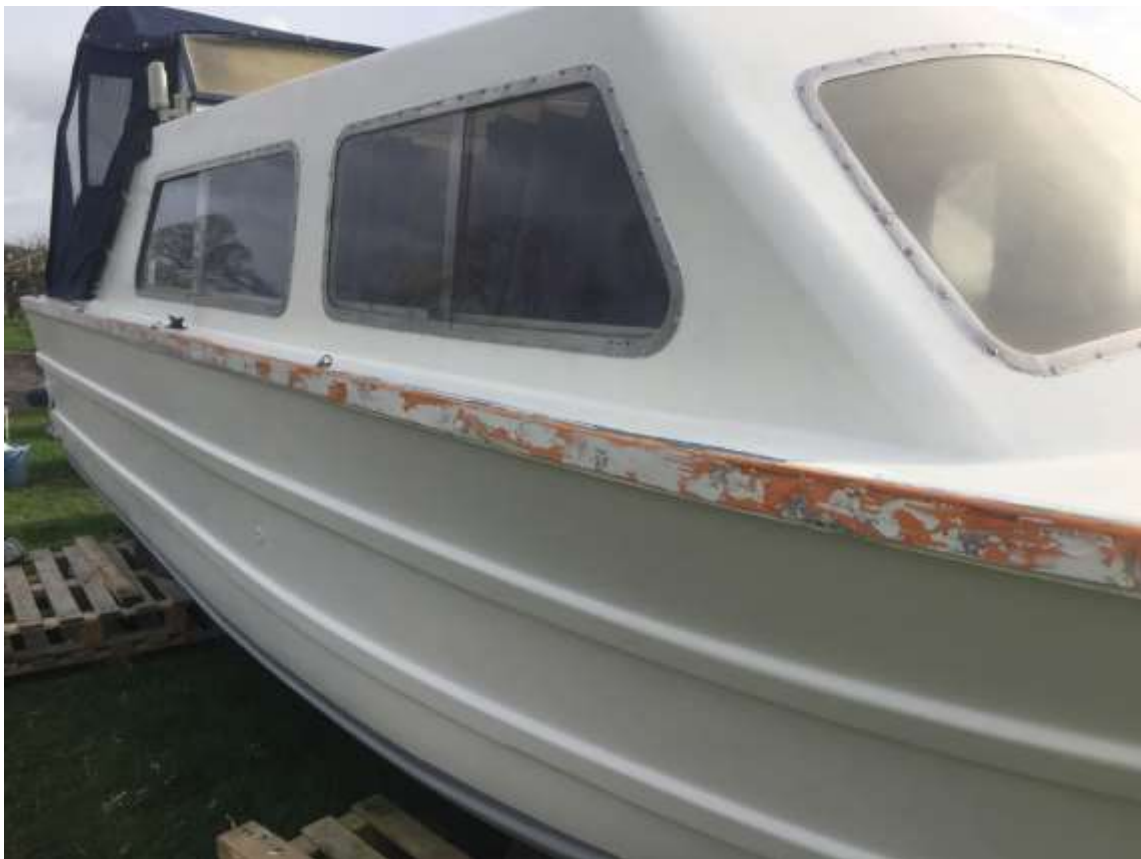
Hull primed and Gunnel stripped of sealant and loose paint (February 2020)

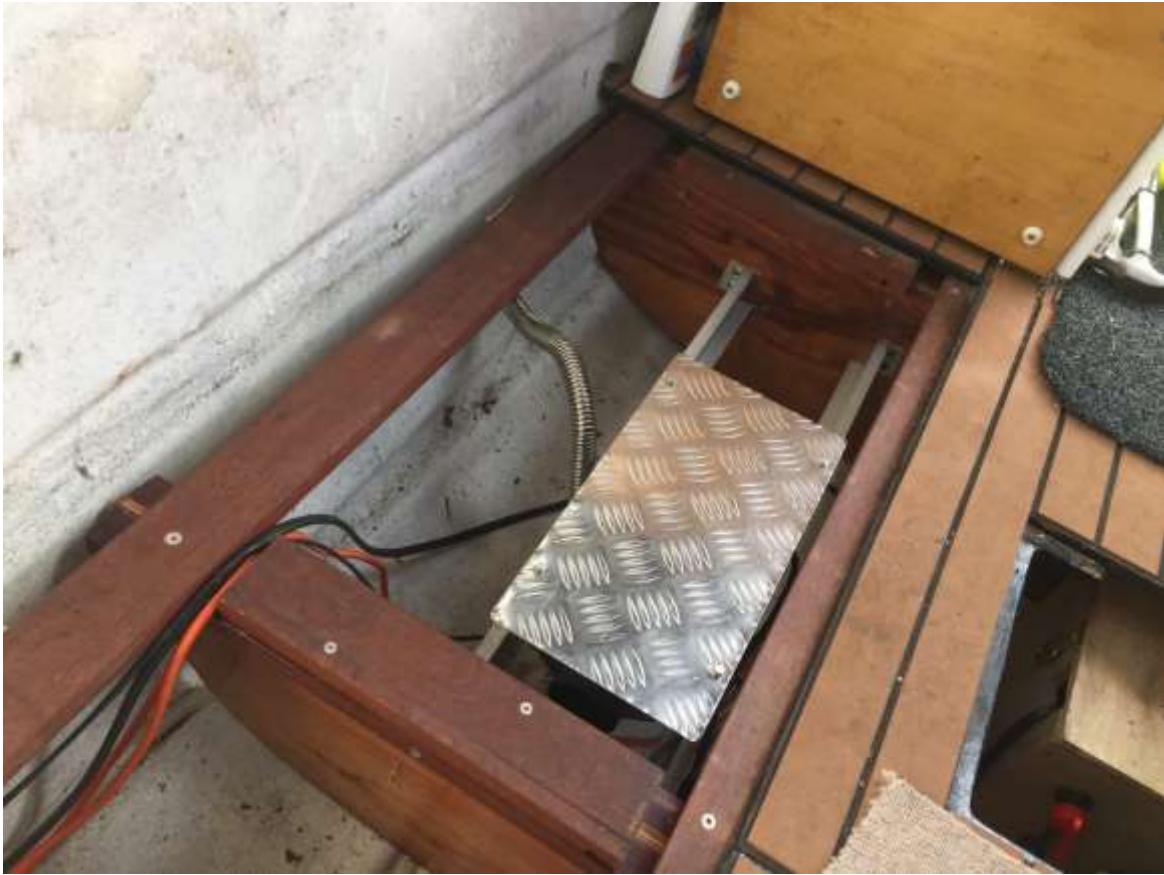
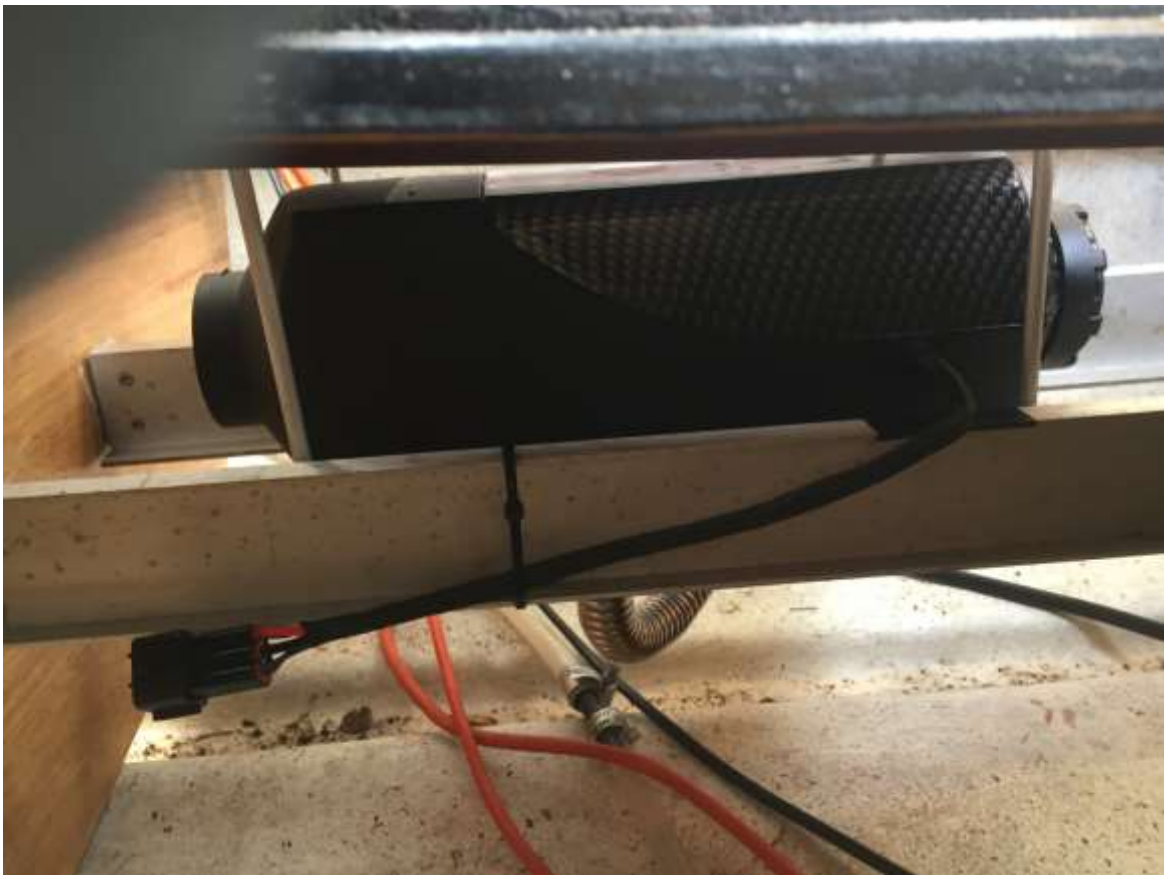
Diesel Air heater fitted below heat shield and deck.

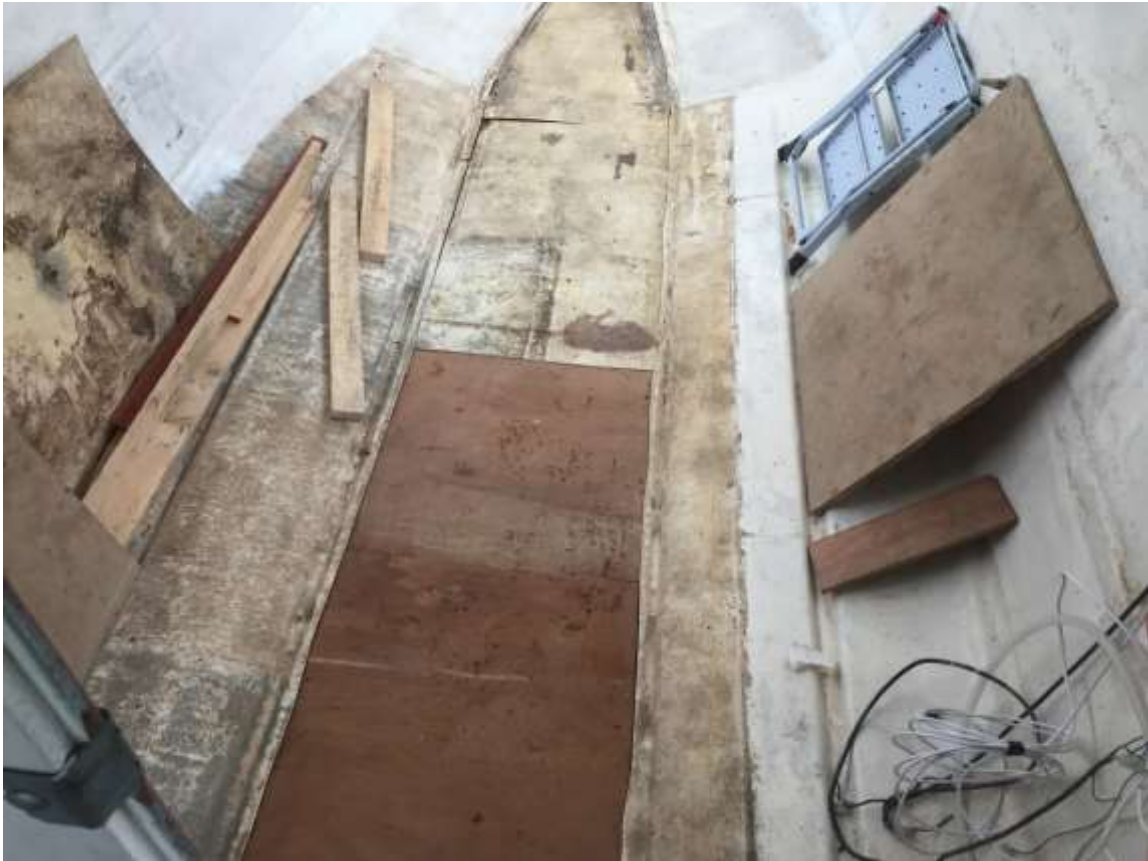
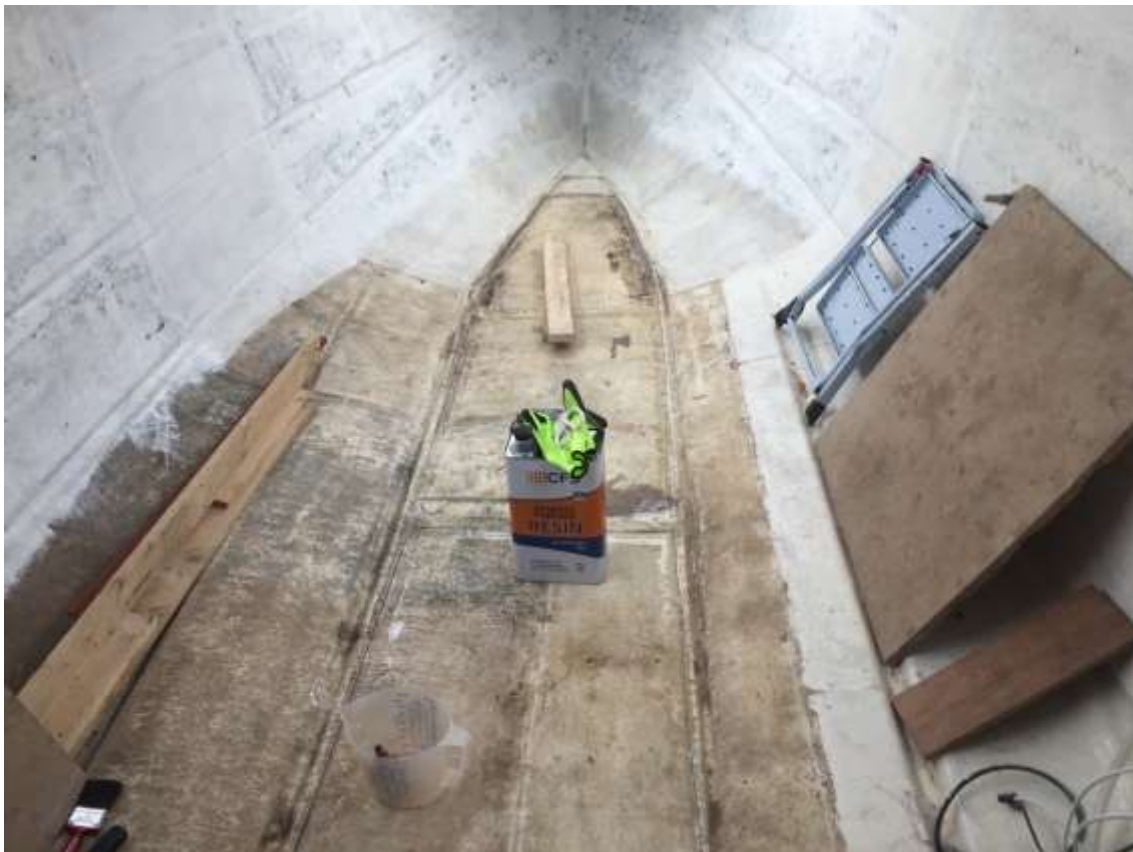
Ballast sand installed and covered with ply and then original fibre glass panels taped and glassed into place.

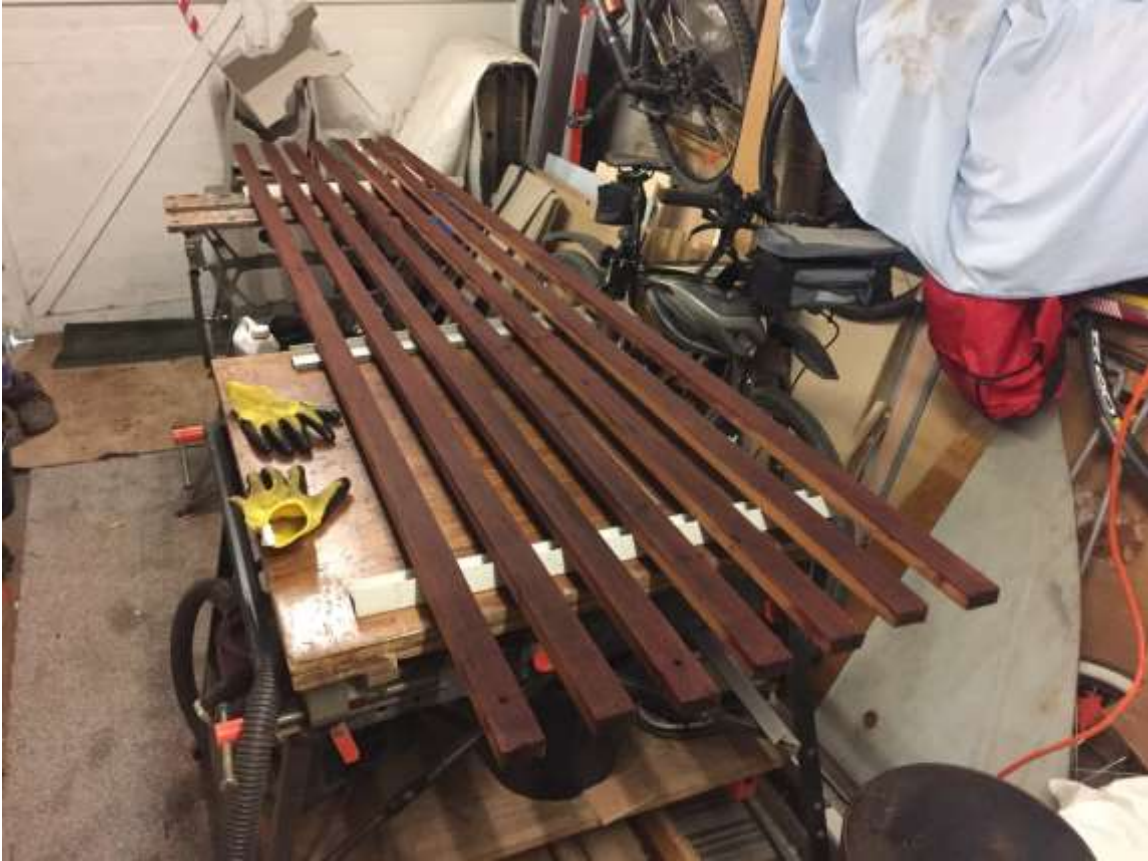
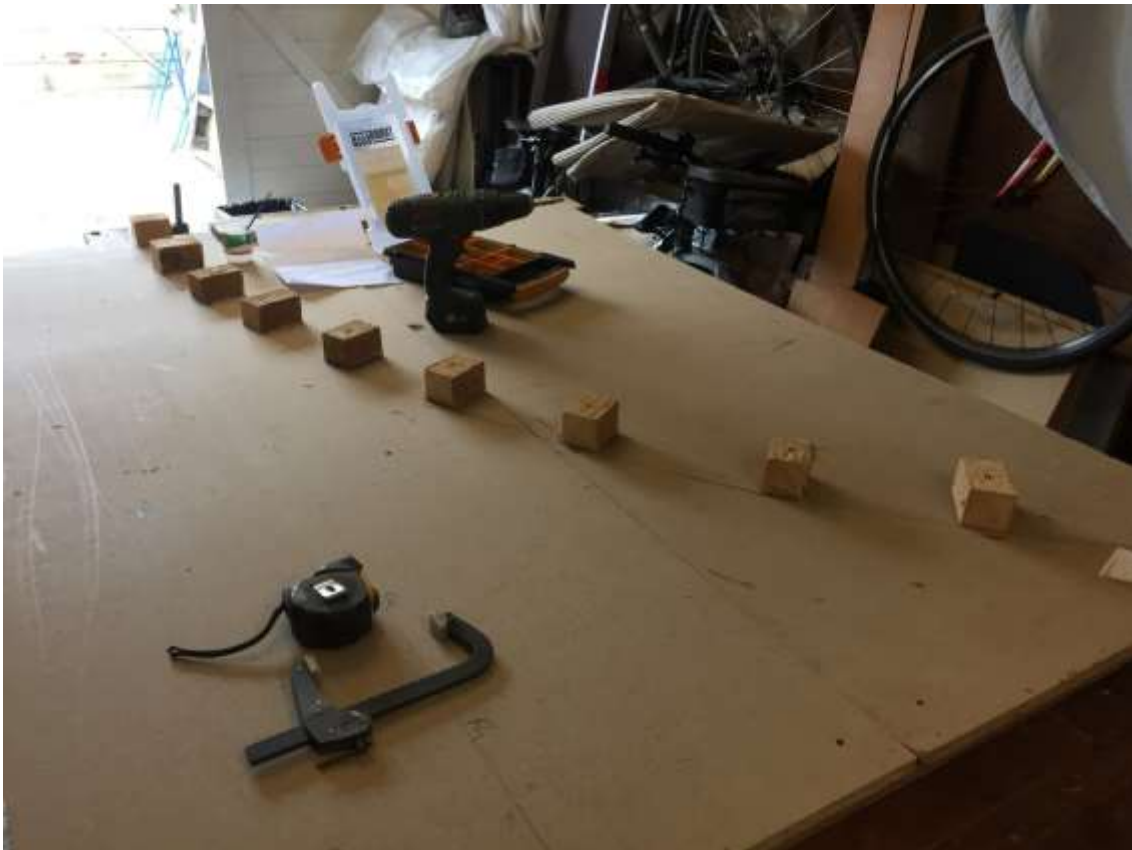
Cut battens of 7/8" x 1 3/4" Mahogany for Gunwale. Stripped old varnish and sanded. Clamping blocks glued and screwed ready for bending gunwale battens.

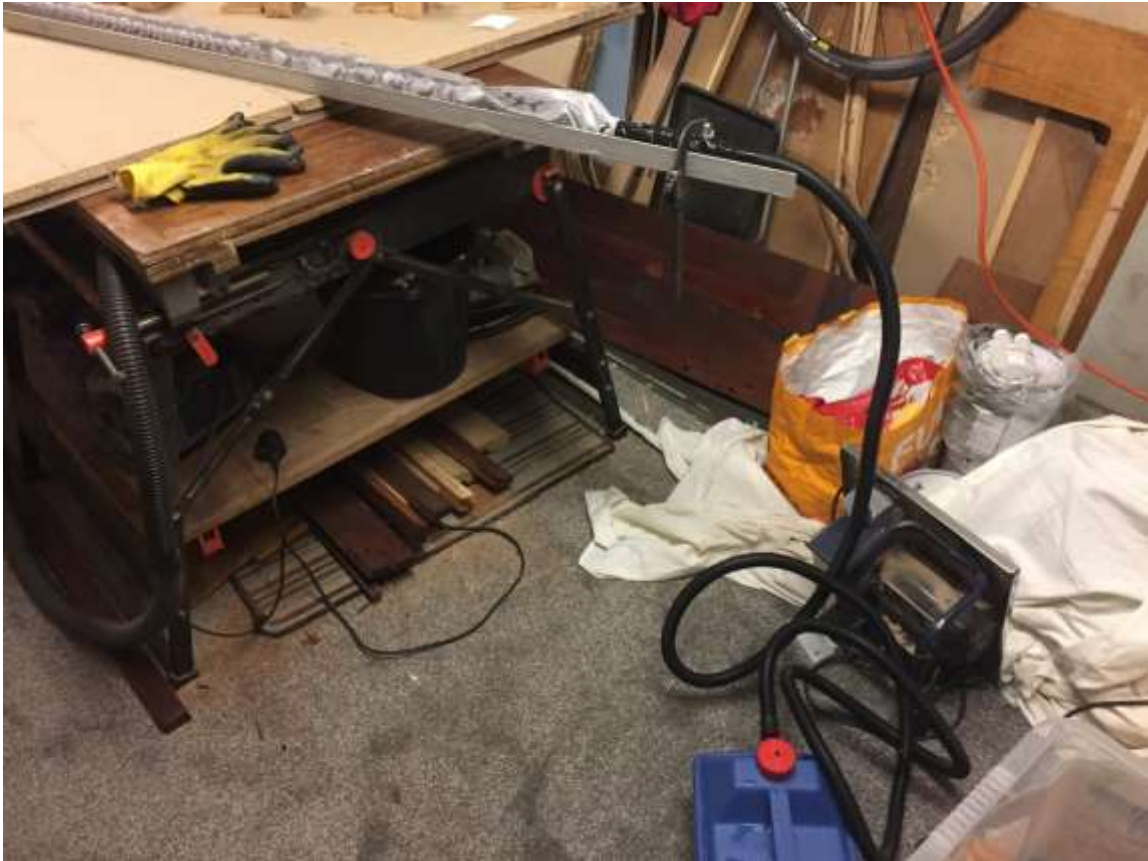
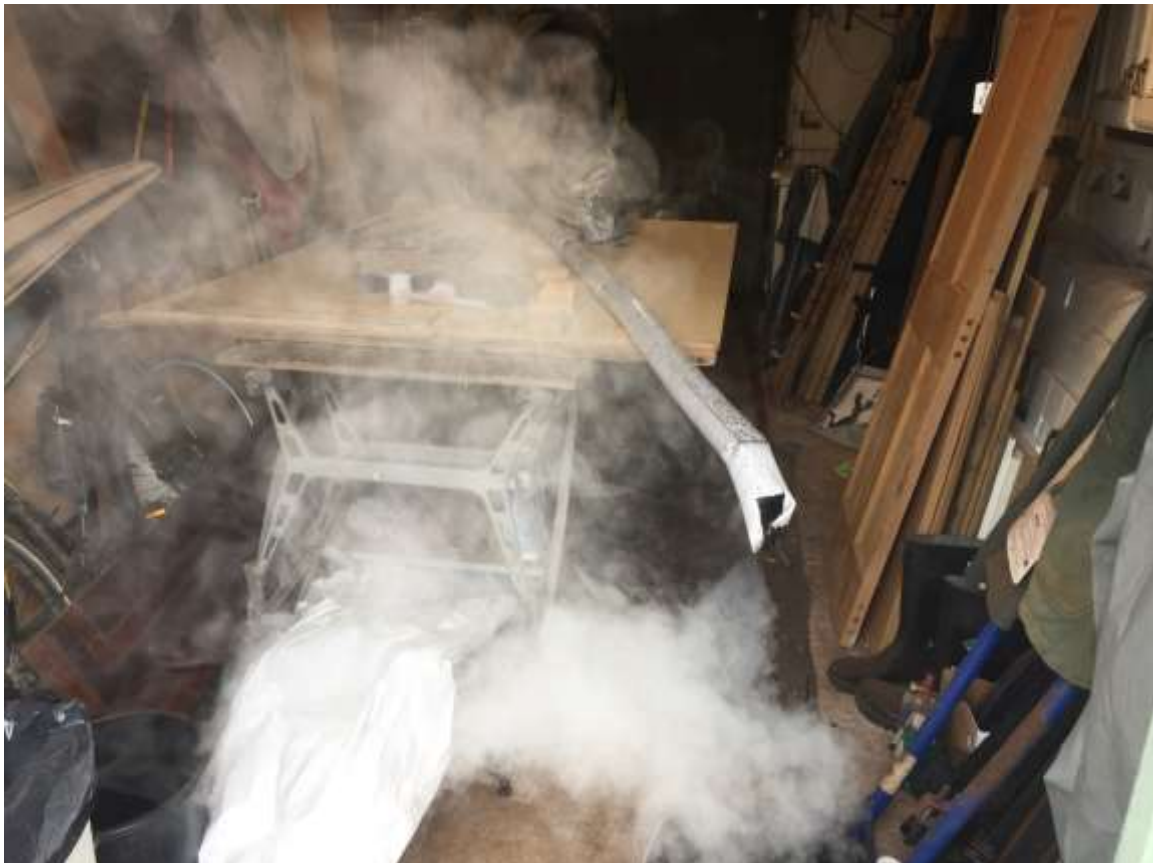
Mahogany batten placed inside layflat poly tubing and fed with steam from wallpaper stripper. Restricted steam flow out to ensure tubing inflated. Steamed for just over 1 hour.

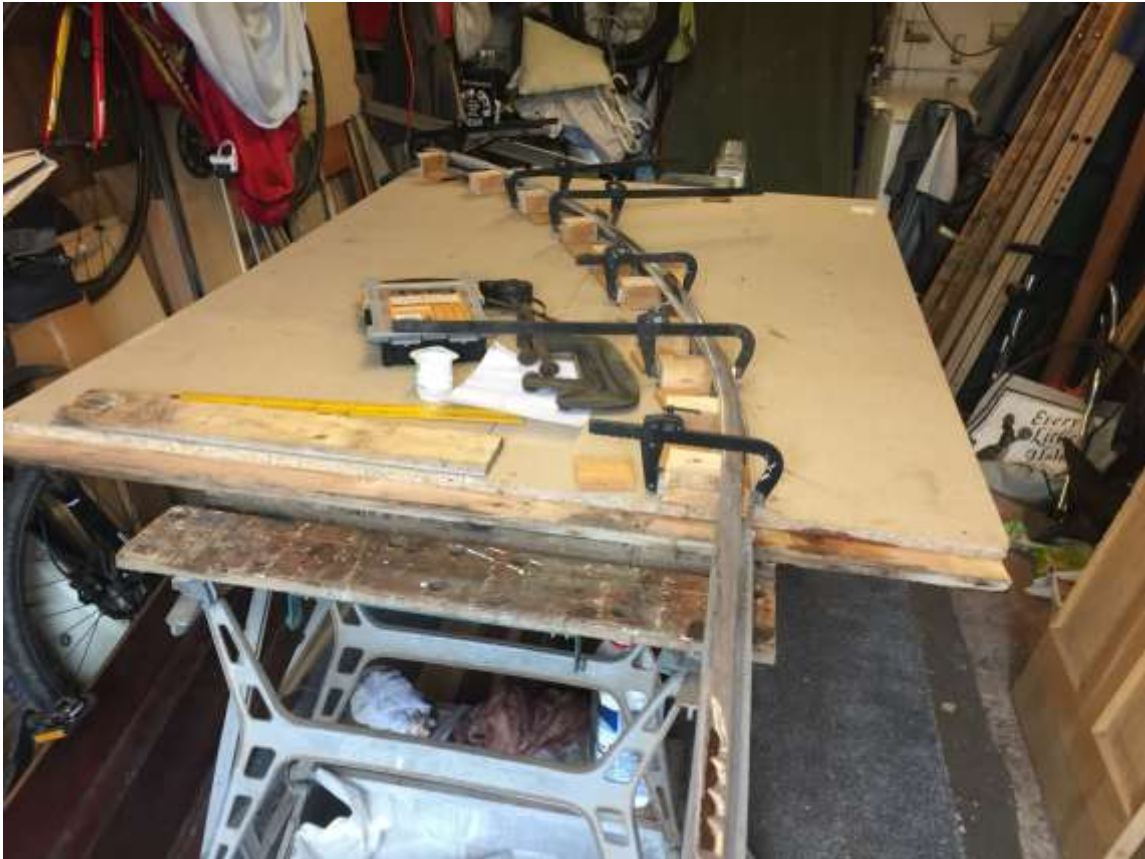
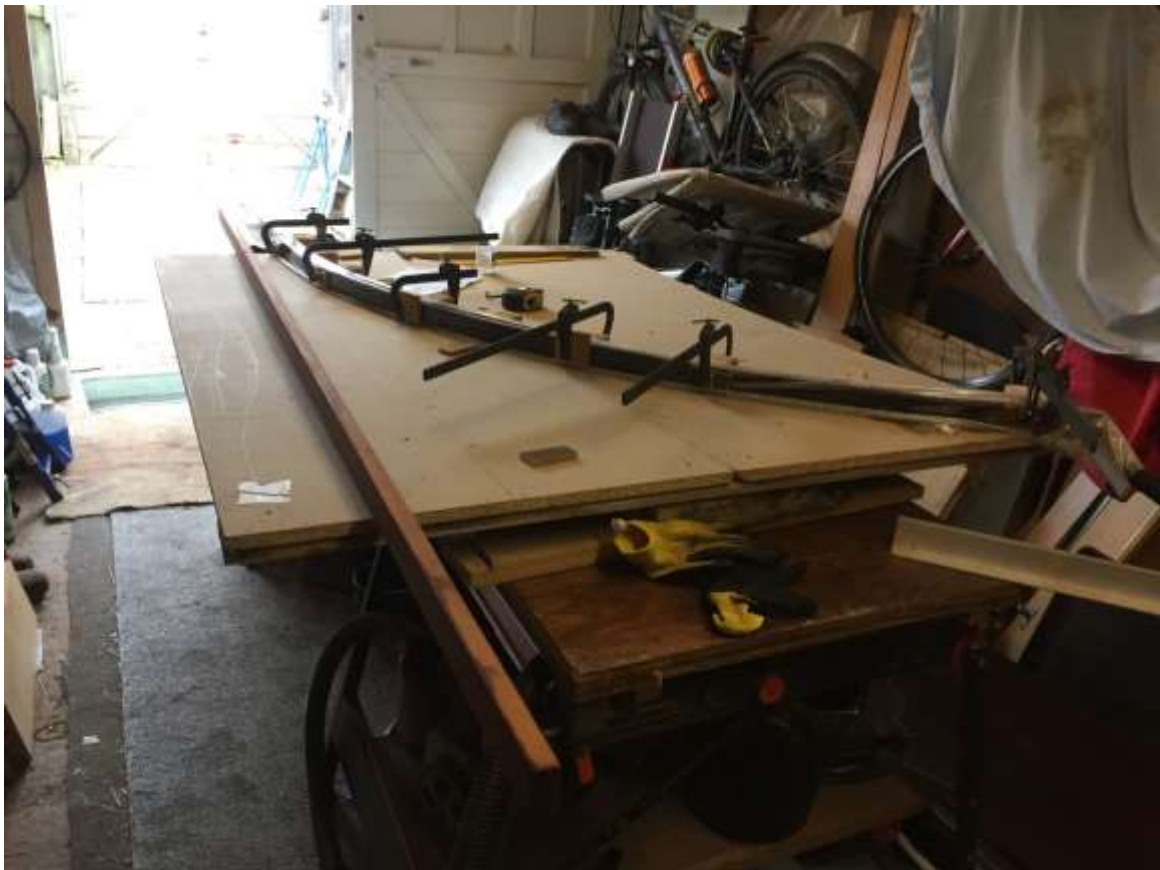
Batten whilst still in poly tube and being steamed clamped and bent to shape.
Example of straight on the left and bent on the right.

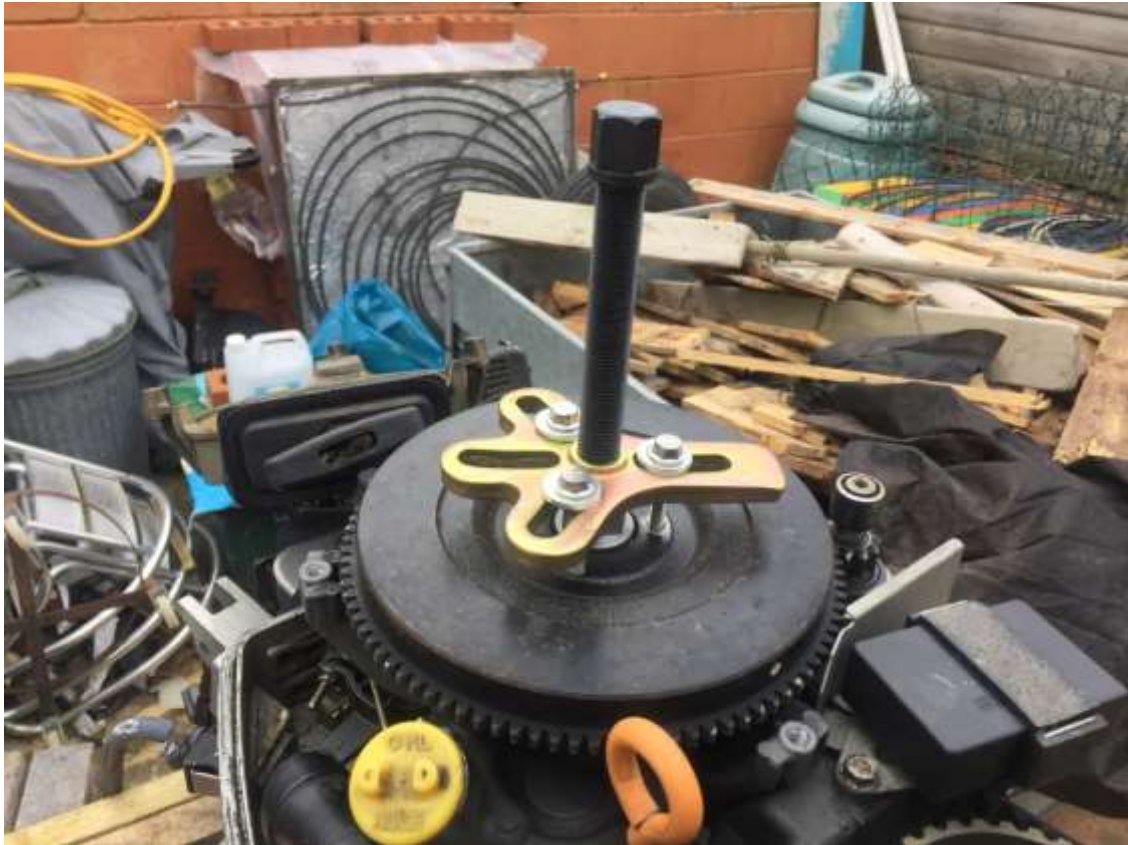
Used new flywheel puller to remove flywheel. Changed timing belt, oil, plugs, fuel filter
(April 4th 2020)

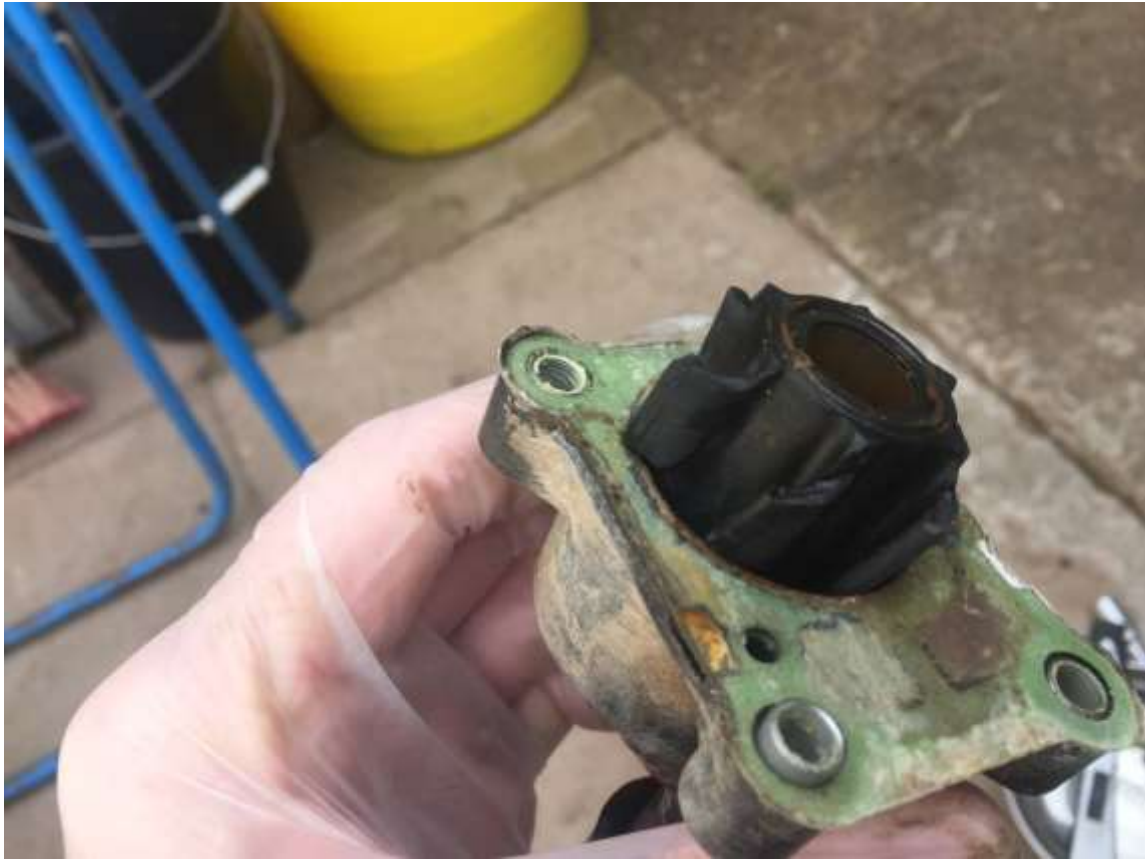
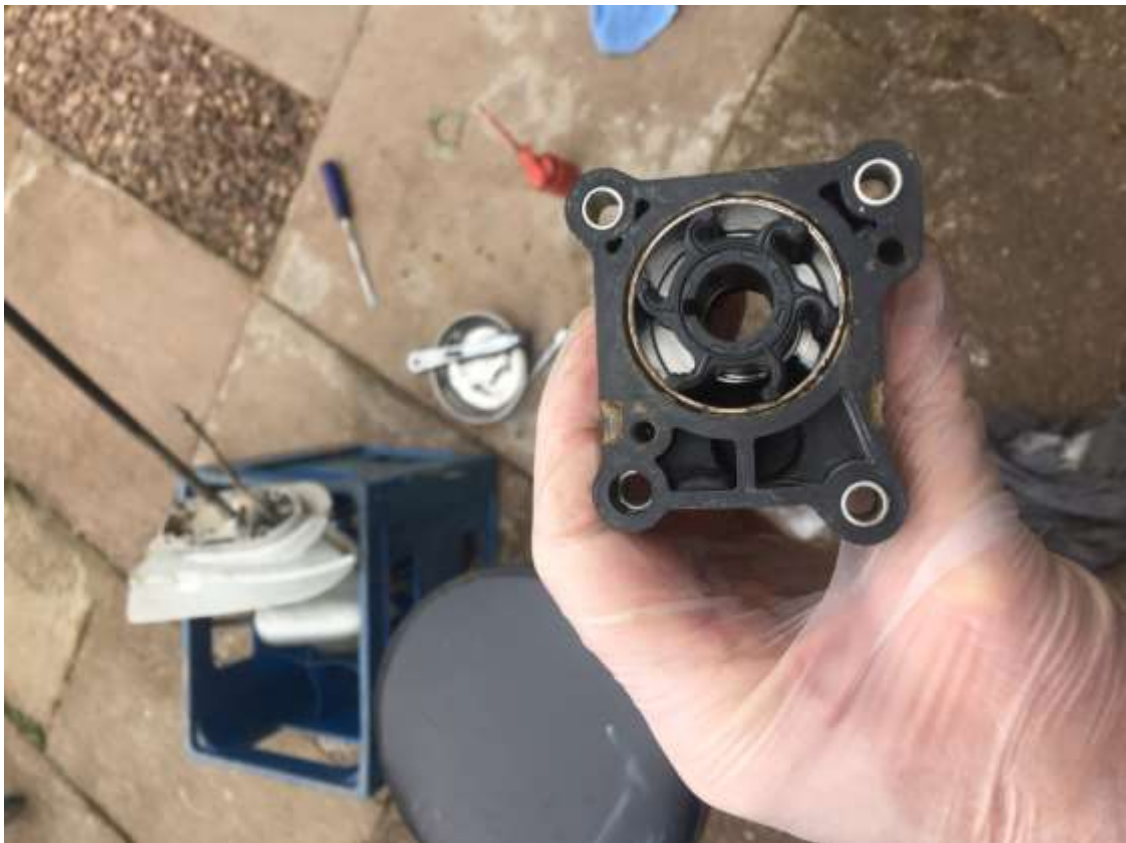
Removed bottom end to change worn out impeller

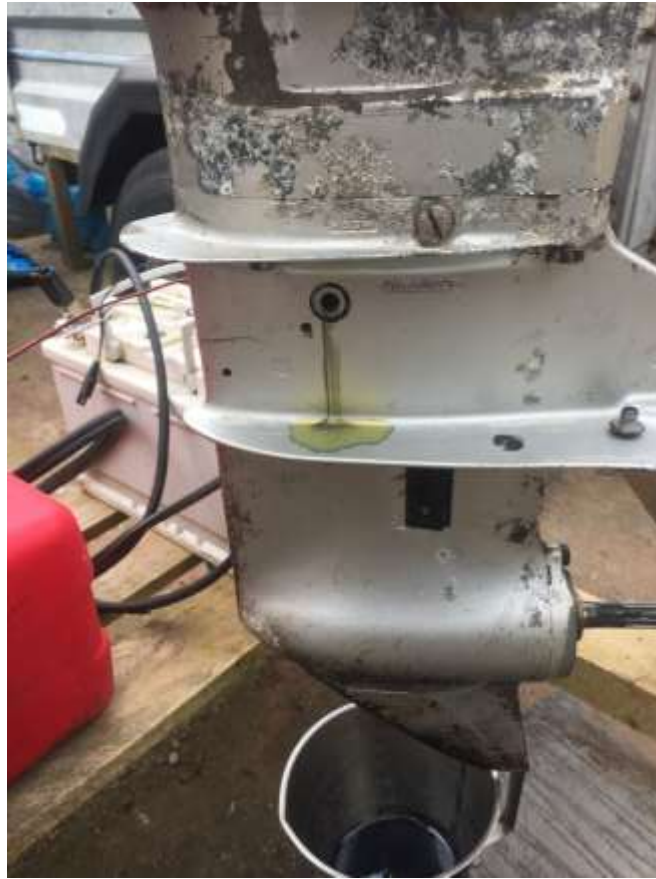
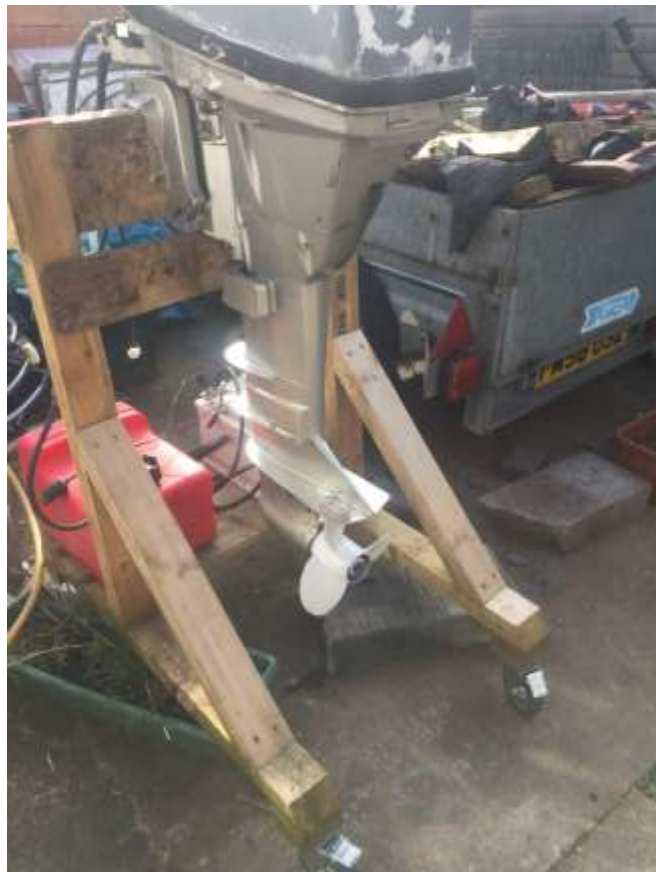
Gear box oil changed. Note the corrosion! (April 5th 2020)
Corrosion treated and primed and finished with Honda silver paint

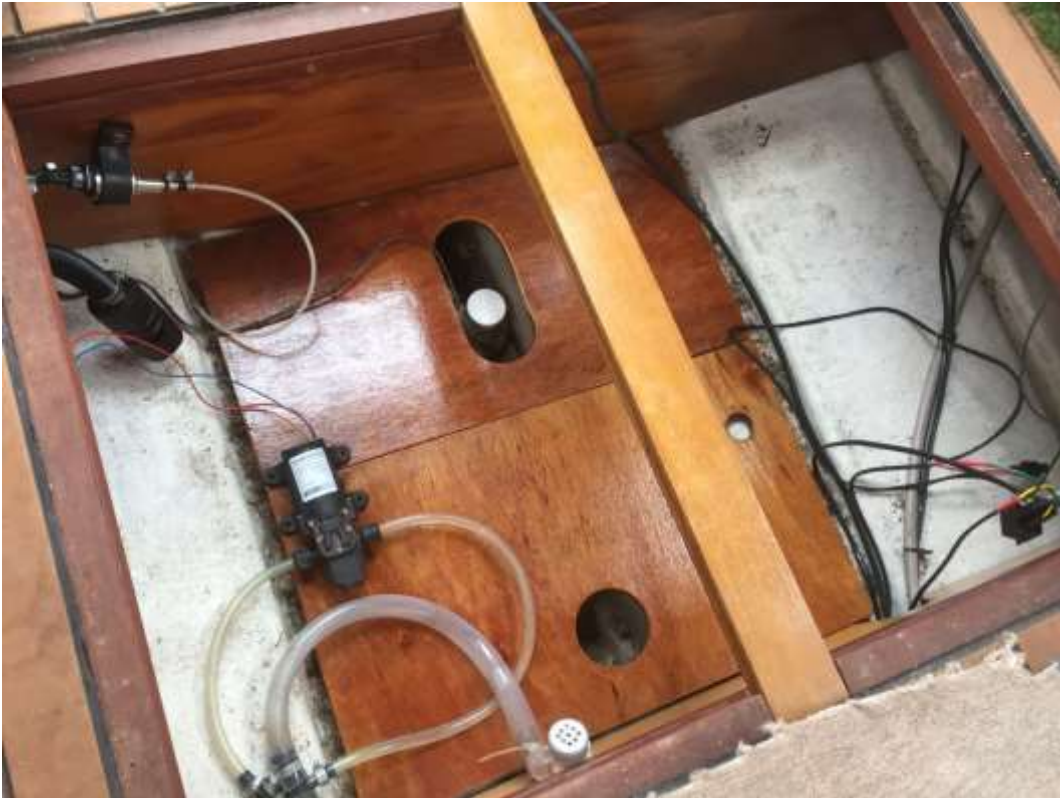
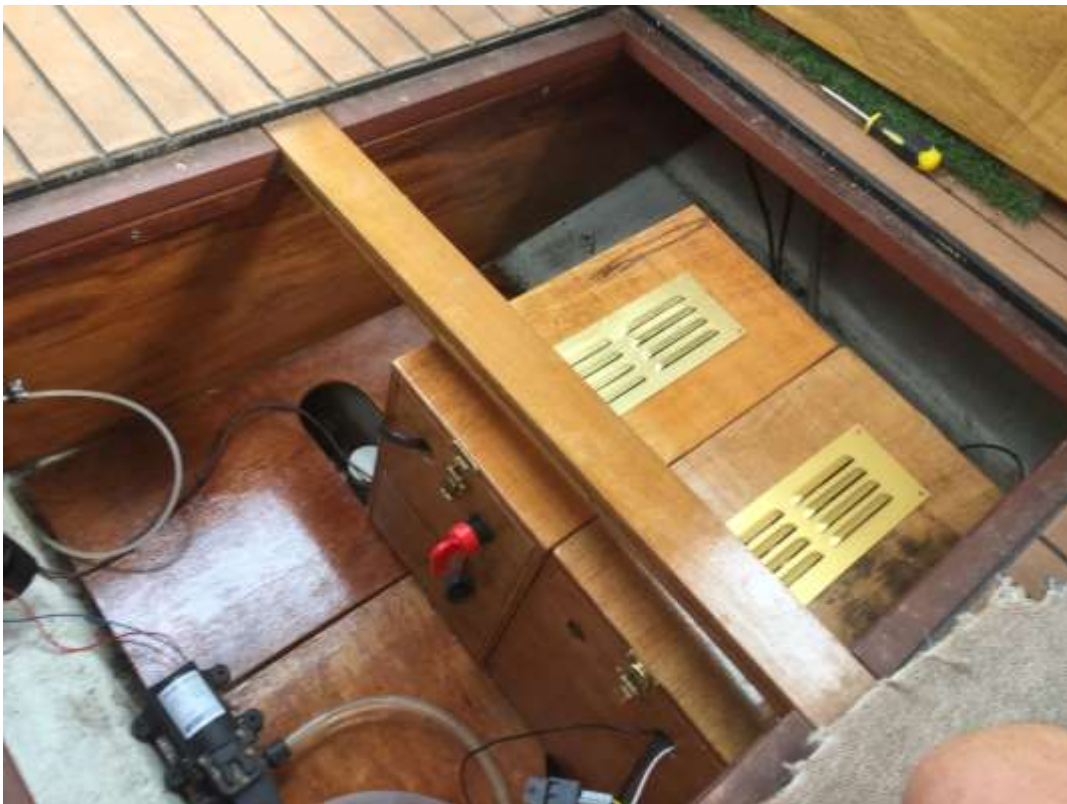
Replaced bilge floor leaving access to bilge pump.
Two new battery boxes. Main and Auxiliary Batteries. (26/04/2020)

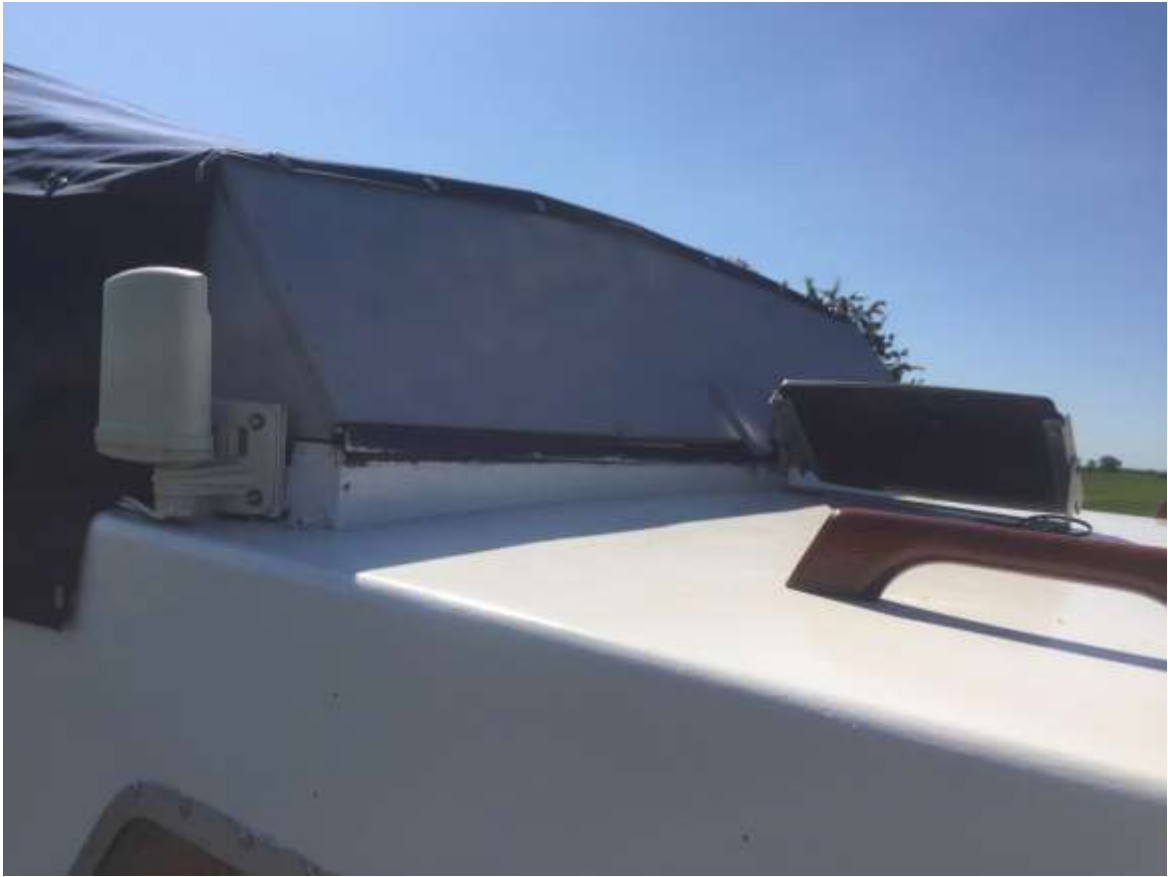
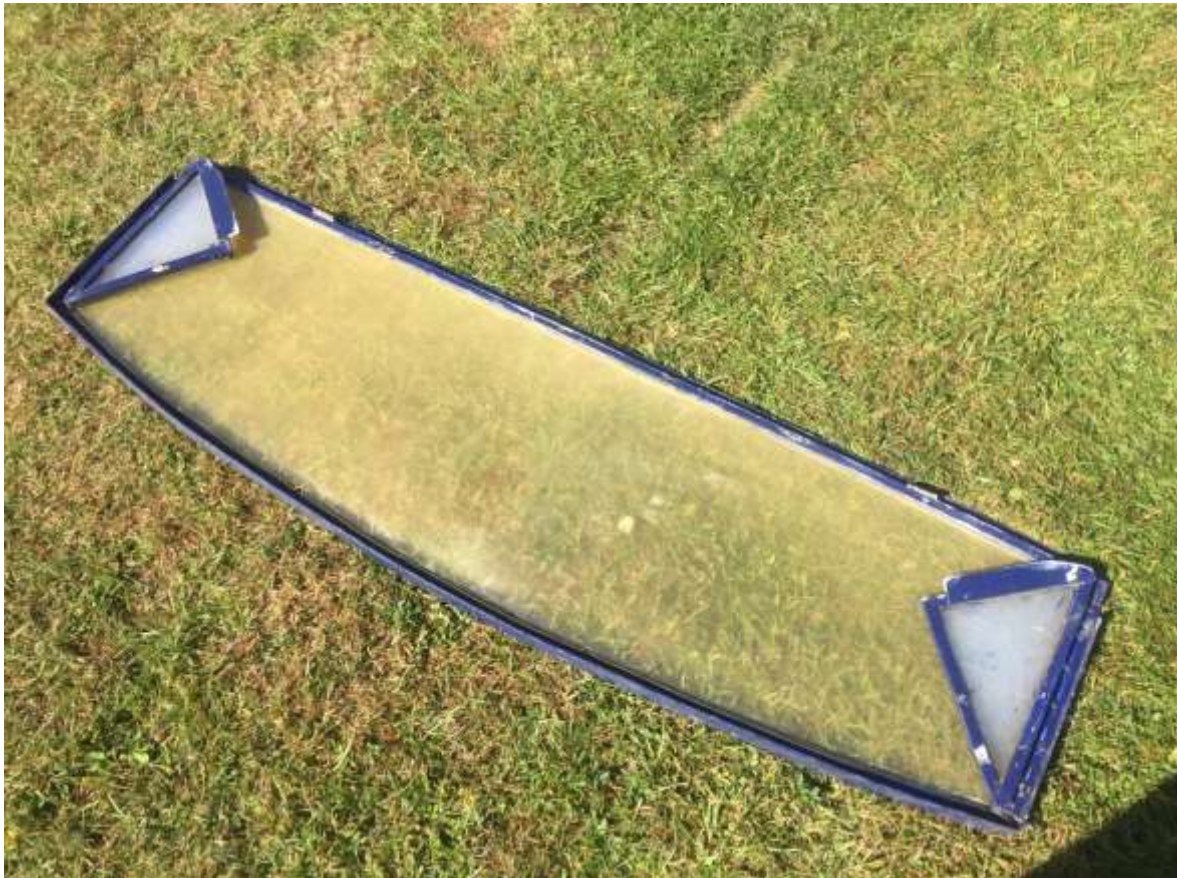
Made and fitted temporary windscreen to enable refurb of old screen.
However decided to make replacement from mahogany (25/5/2020)
